Elliott Ditch Project Update

Date: January 8, 2024

Subject: Elliott Ditch Project Update No. 56

Reach 5 & 6 Isolated Soil Remediation Project

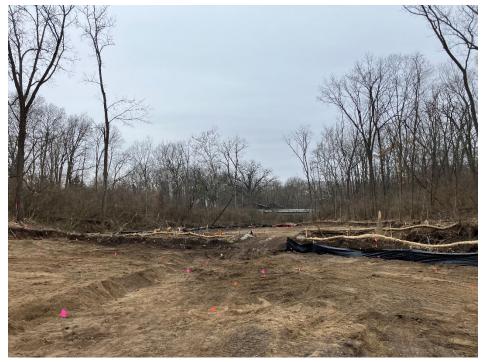
Photopgraph 1: Excavation bottom being prepared for sampling.
