FLOODWAY HABITAT MITIGATION PLAN

**ELLIOTT DITCH – LEVEE REMEDIATION
ARCONIC LAFAYETTE OPERATIONS
3131 EAST MAIN STREET
LAFAYETTE, INDIANA 47905**

CEC PROJECT 172-367.0043

**OCTOBER 2019
UPDATED JANUARY 2021**

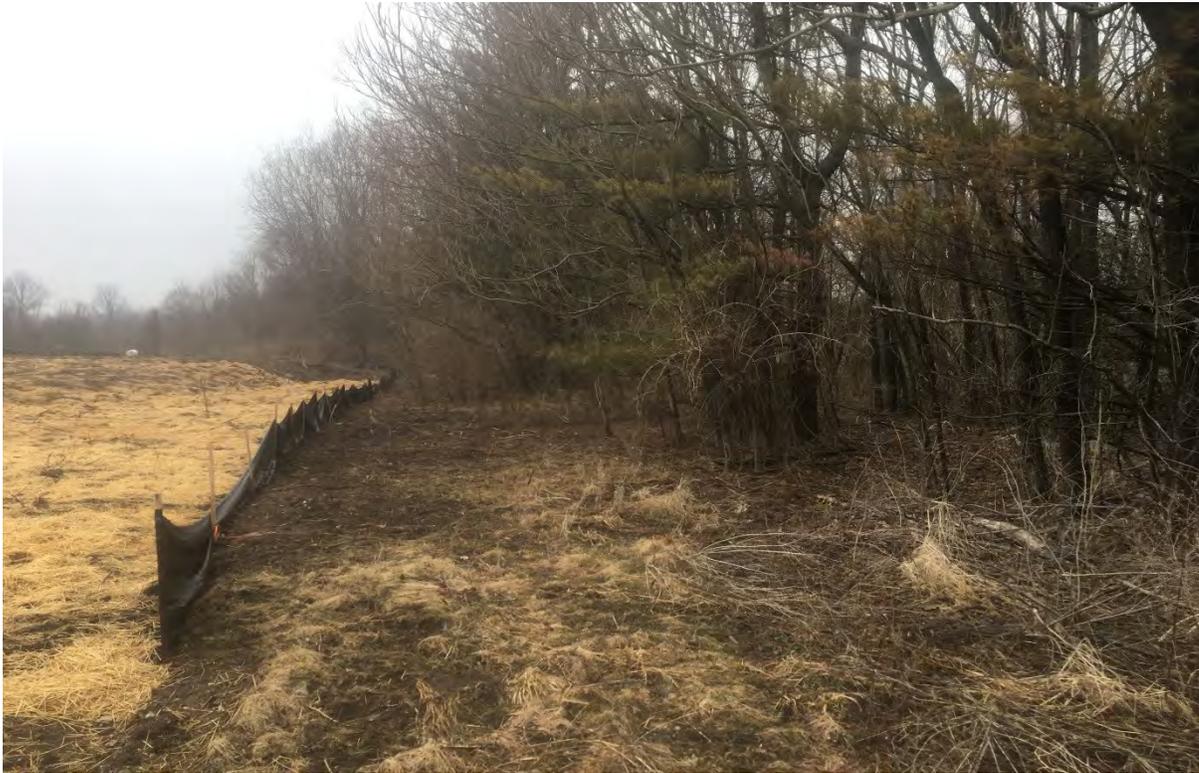
Photo 1: Levee view from northeast extent, facing southwest (Location 1) (Photo Date: 3/21/19)

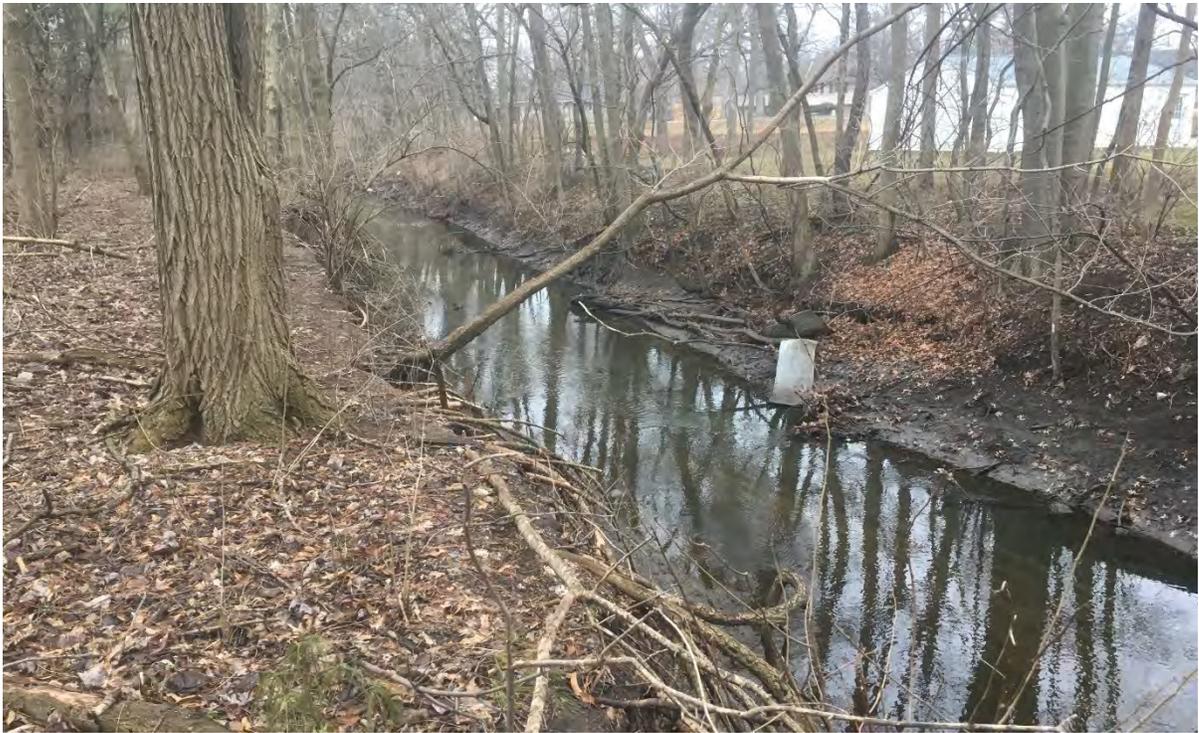
Photo 2: Elliott Ditch bank conditions, facing southwest (Location 1) (Photo Date: 3/21/19)

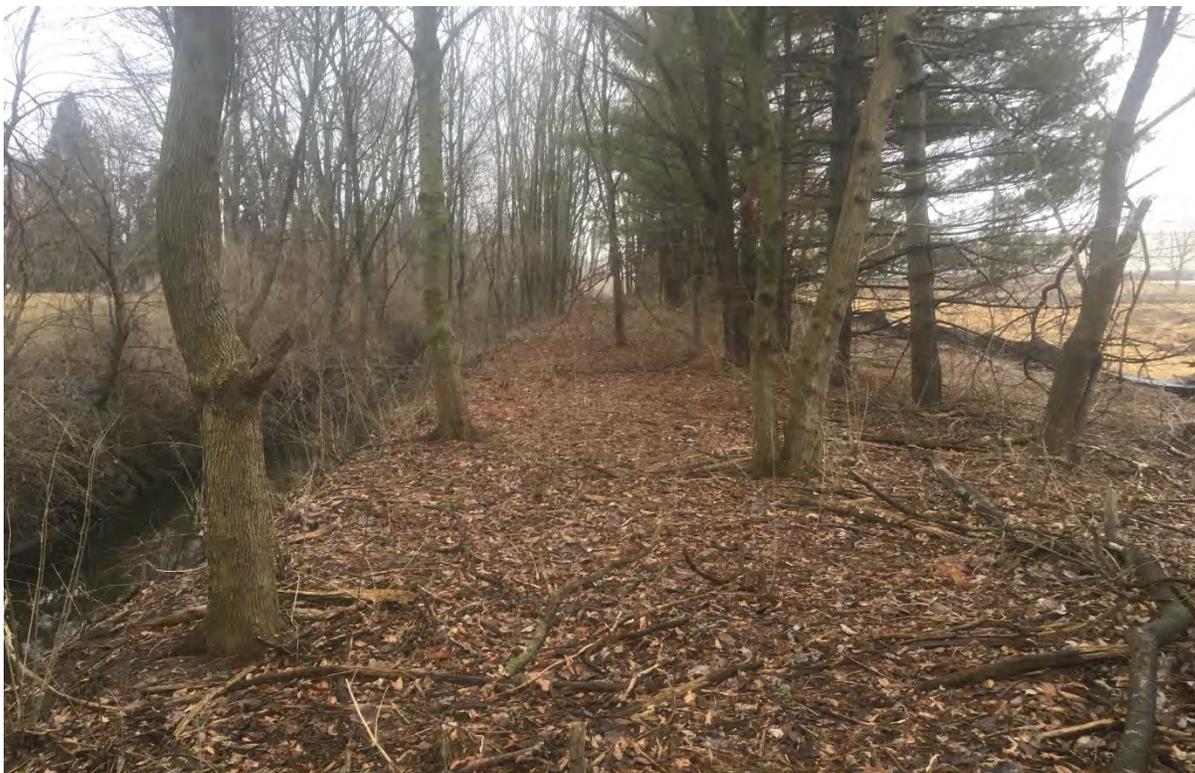
Photo 3: Levee/Elliott Ditch bank view, facing northeast (Location 2)*

*Clearing and grubbing of this area was completed in March 2020 in accordance with approved IDNR Construction in a Floodway Permit (FW-29895-0). The area was stabilized after remedial activities with native grasses. Mitigation will be completed per the approved Floodway Habitat Mitigation Plan as part of Permit FW-29895-0.

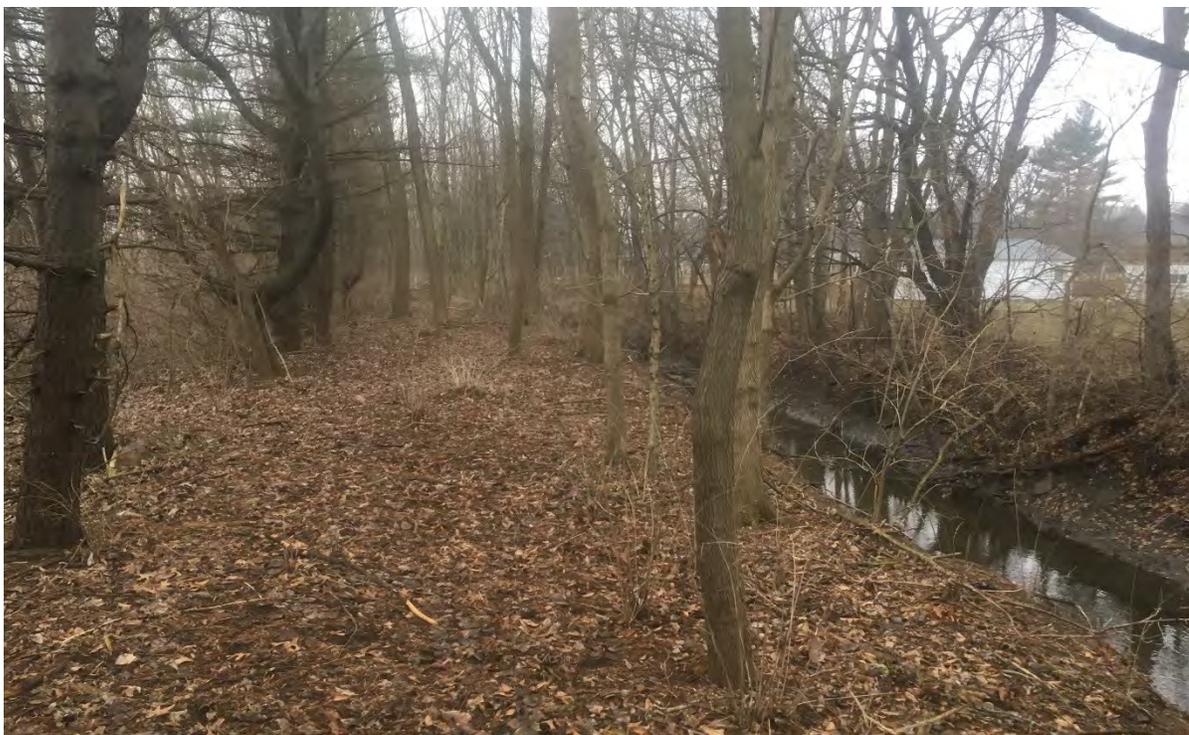
Photo 4: Levee/Elliott Ditch bank view, facing southwest (Location 2)*

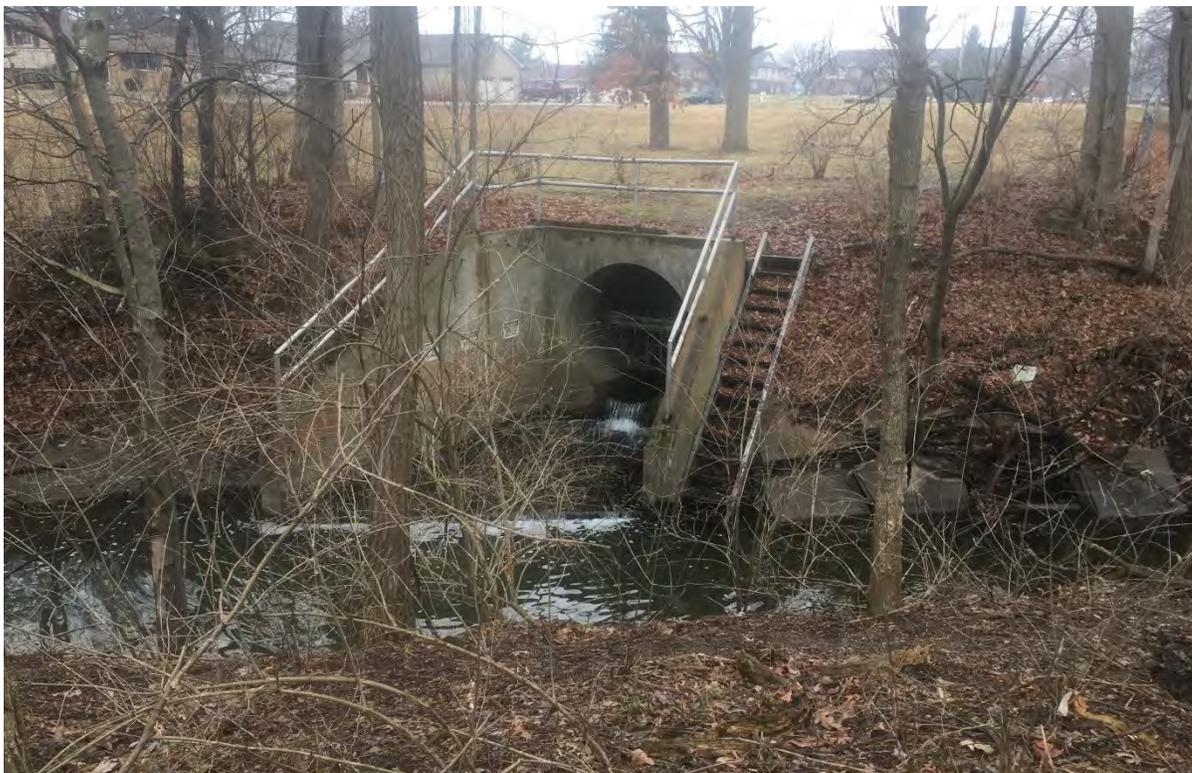
Photo 5: Arconic Outfall 001, showing Elliott Ditch bank conditions, facing west (Location 3)*

*Clearing and grubbing of this area was completed in March 2020 in accordance with approved IDNR Construction in a Floodway Permit (FW-29895-0). The area was stabilized after remedial activities with native grasses. Mitigation will be completed per the approved Floodway Habitat Mitigation Plan as part of Permit FW-29895-0.

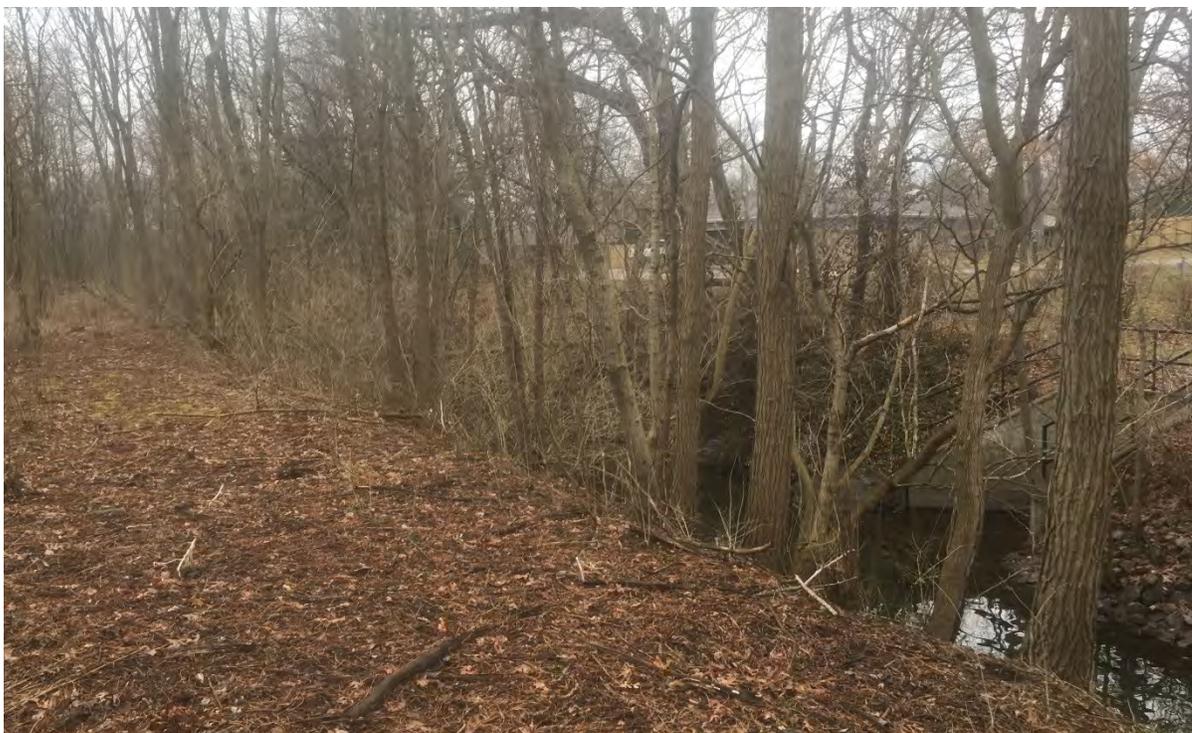
Photo 6: Levee/Elliott Ditch bank view showing Outfall 001, facing southwest (Location 2)*

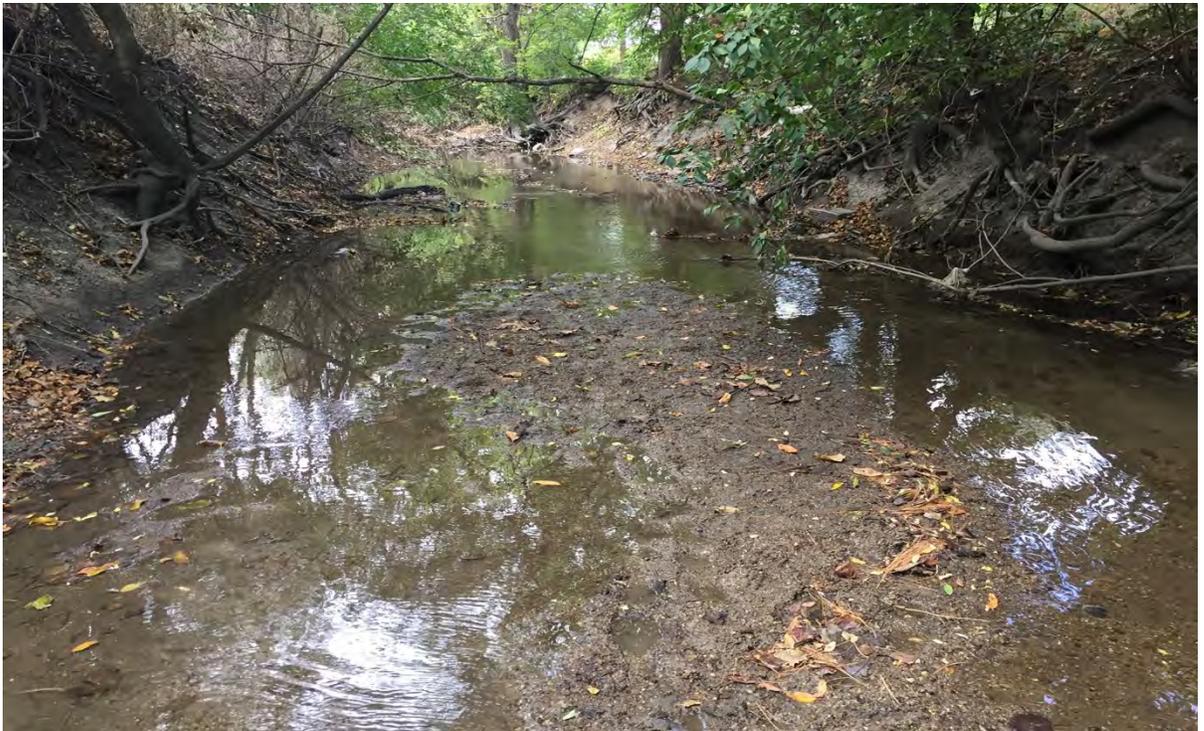
Photo 10: Elliott Ditch conditions, longitudinal bar, facing southwest, downstream (Location 4)
