**Elliott Ditch Geomorphic
Surface Mapping and Historic Data Review
July 6, 2015**

Prepared for Alcoa

**Prepared by Tetra Tech CES
Submitted: July 6, 2015**

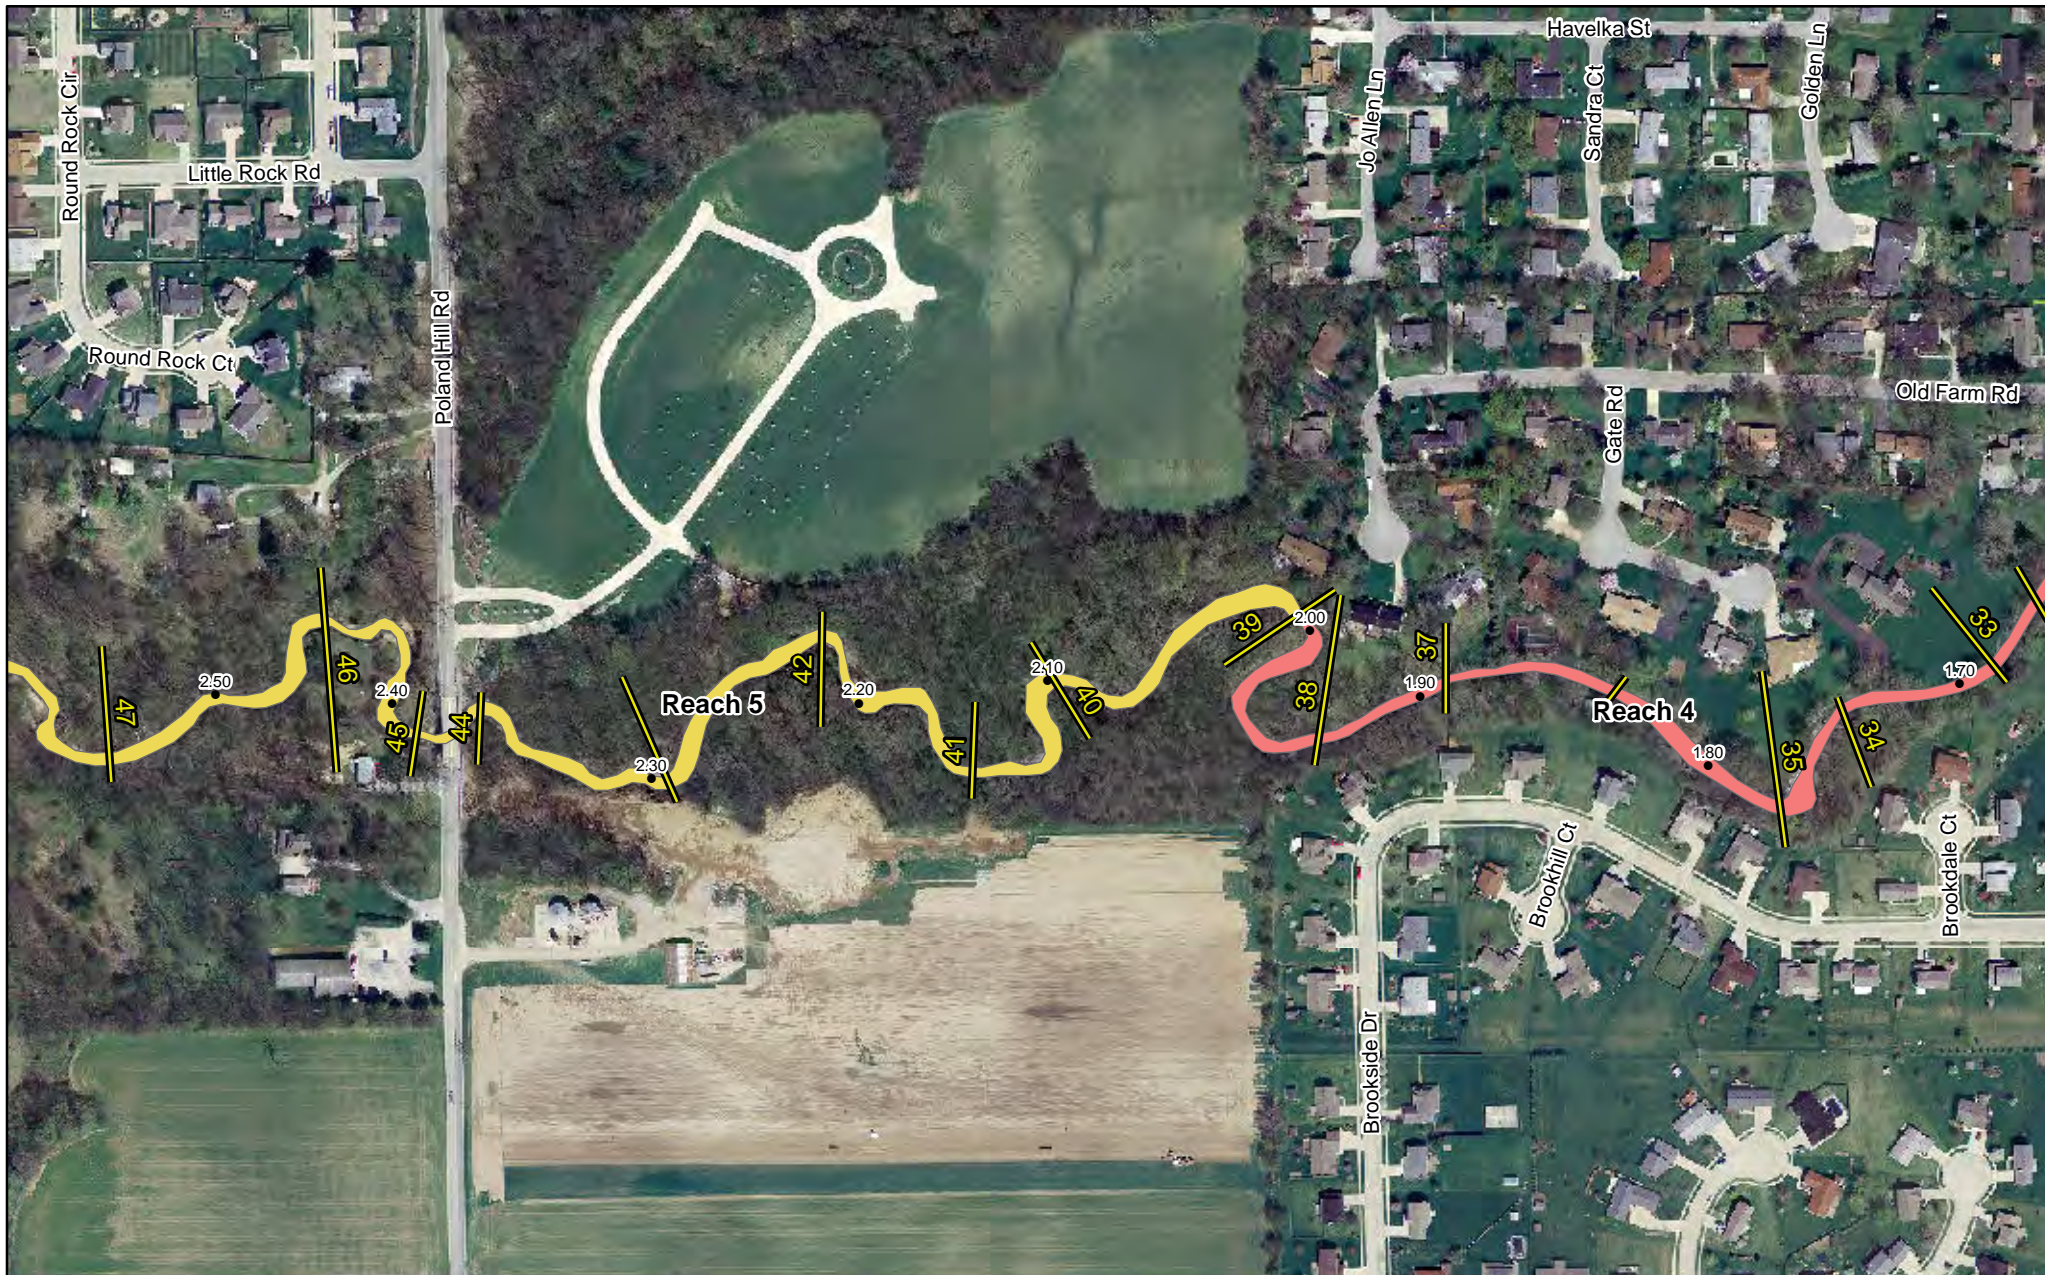
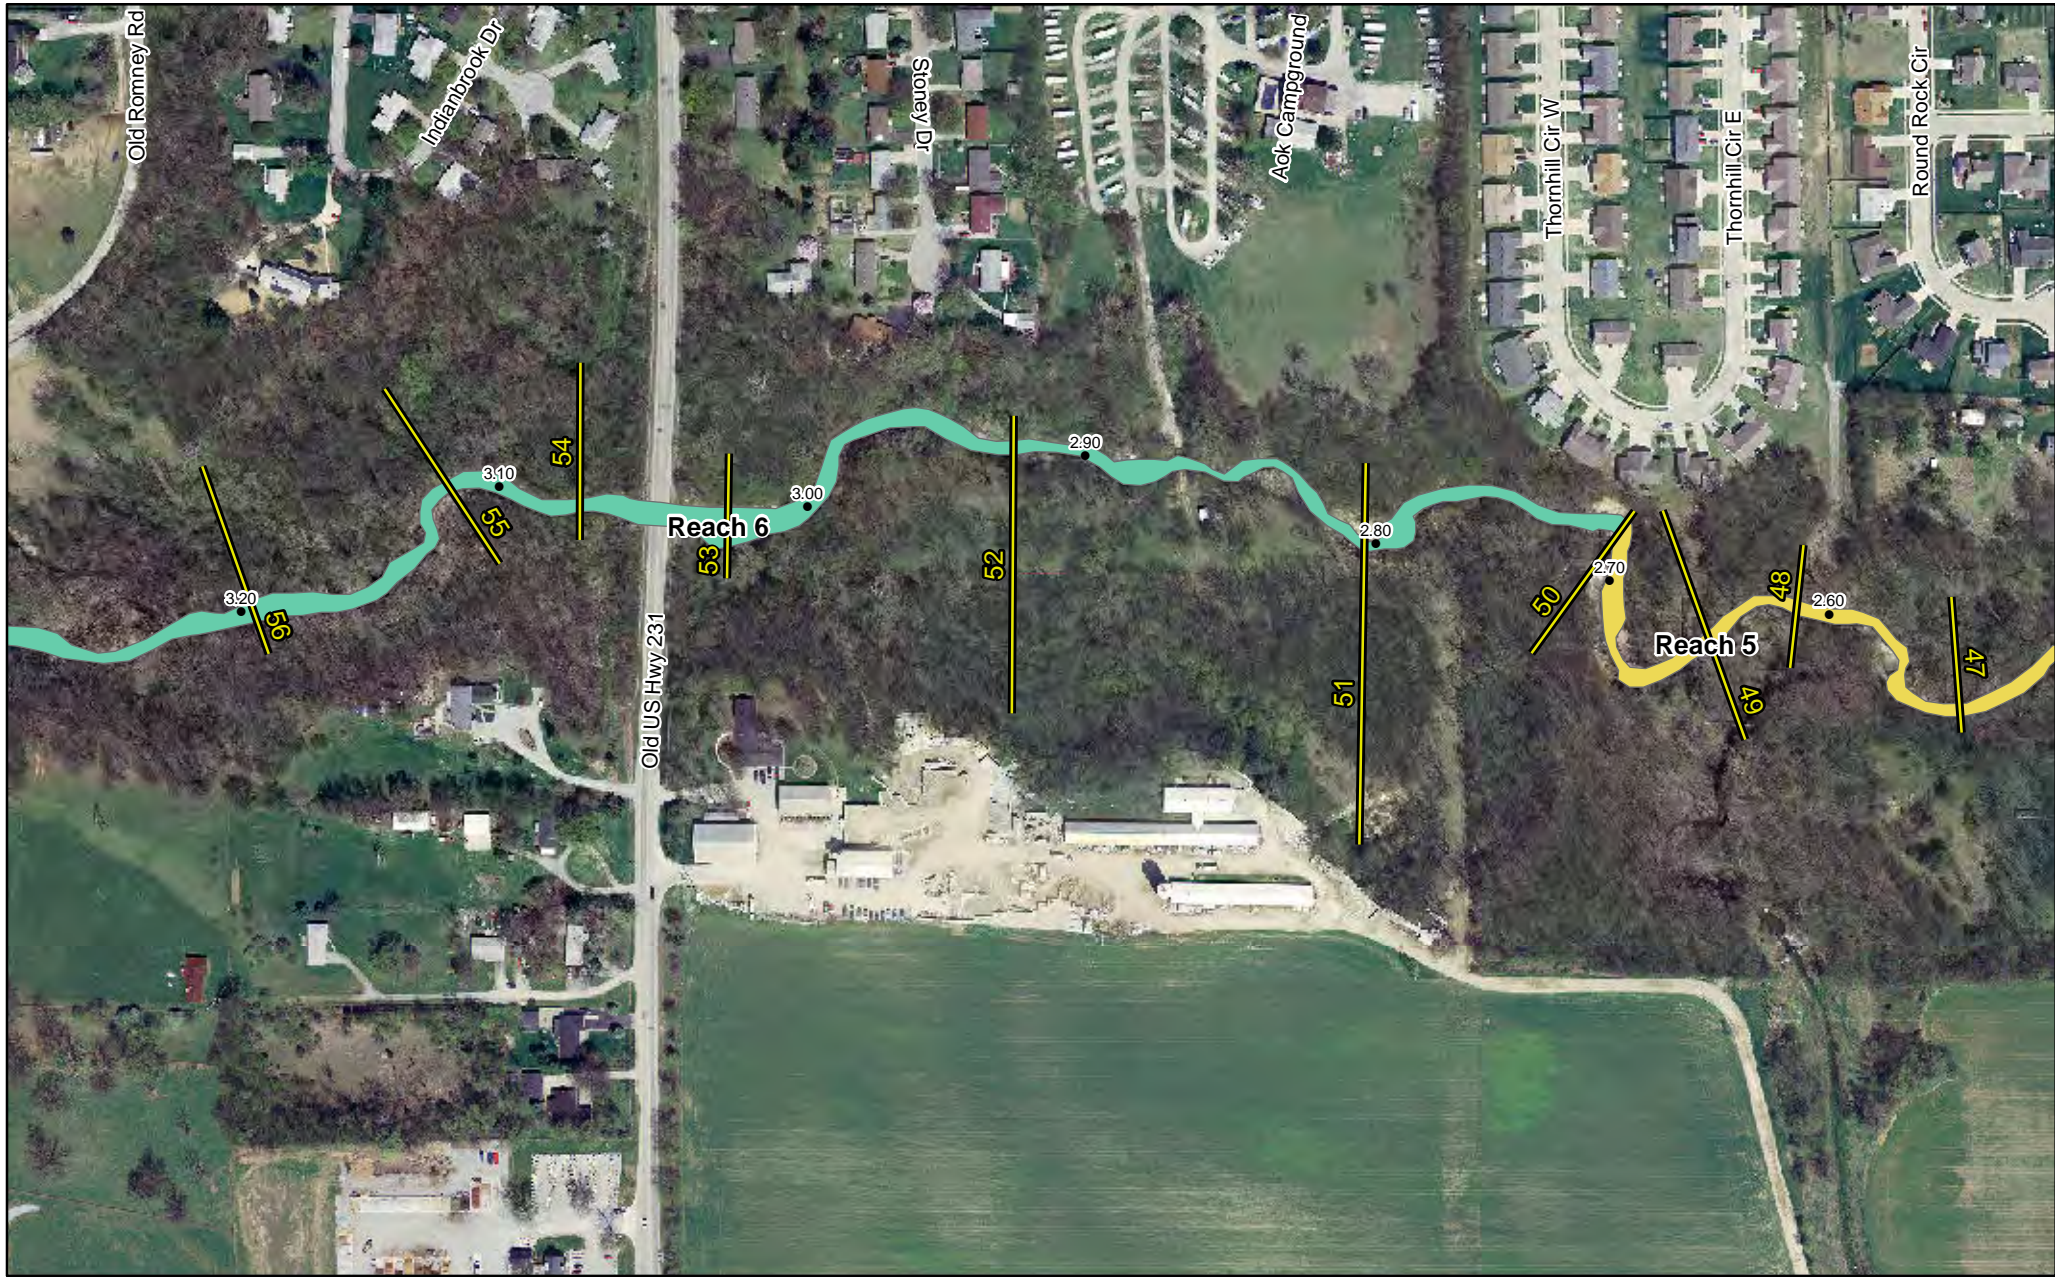
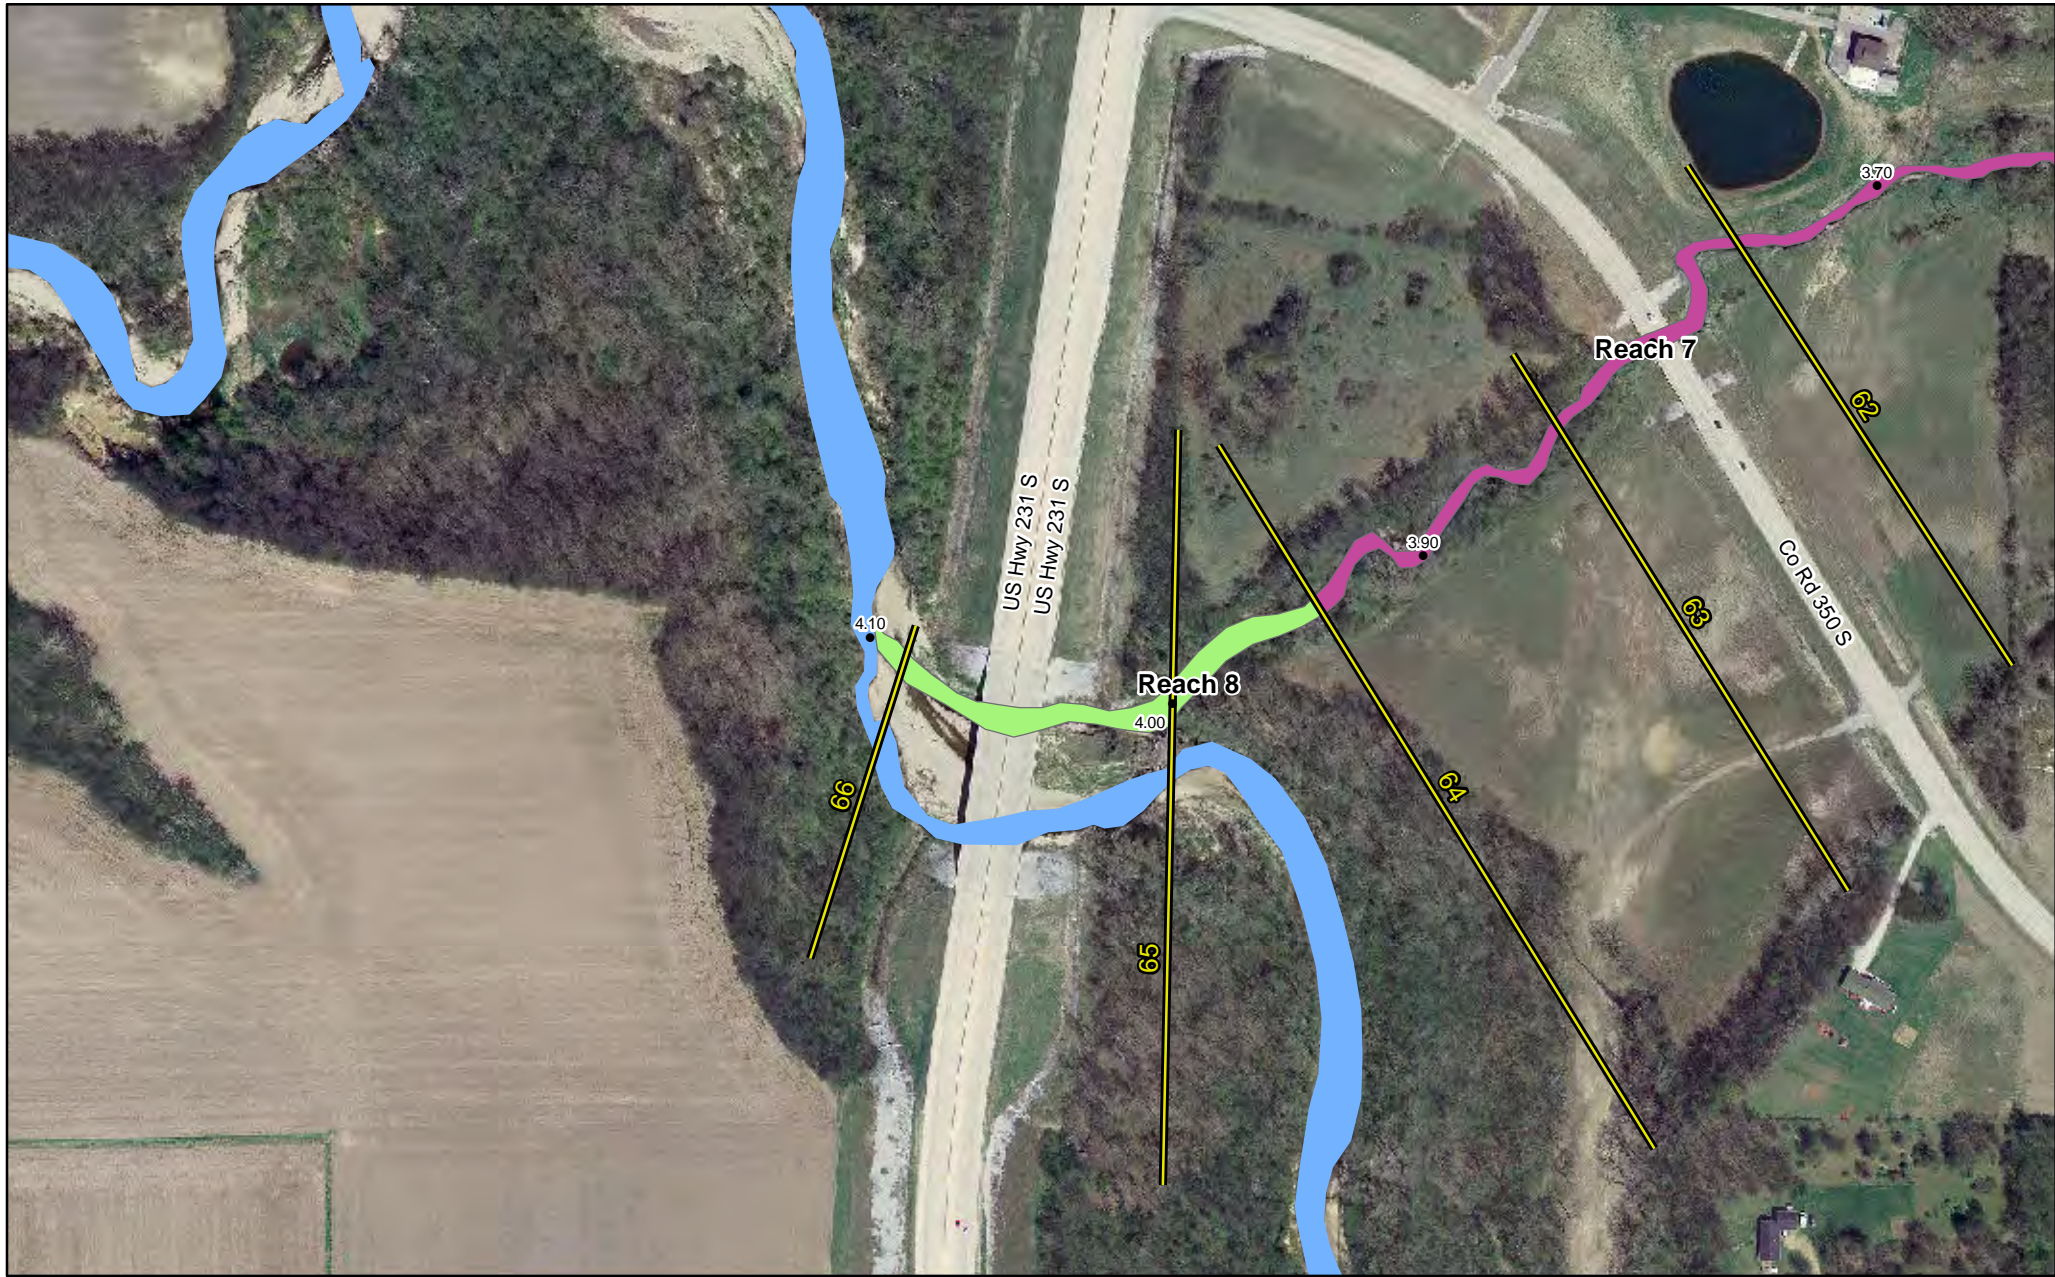
Figure 2

Stream Reaches and Survey Transects

Reach 1 of Elliott Ditch is characterized by a relatively straight channel, steep valley walls, and no stream terraces (Figure 2, Appendix A). The longitudinal profile (Figure 4, Appendix A) for Segment 1 indicates a relatively shallow gradient (0.4 feet/mile) compared to downstream reaches. While some erosion is occurring along the channel banks and immediately downstream of the outfall, deposition is occurring within the stream in pools in areas of relatively fine-grained sediment. The erosional/depositional areas of Reach 1 are presented in Figure 5 (Appendix A).

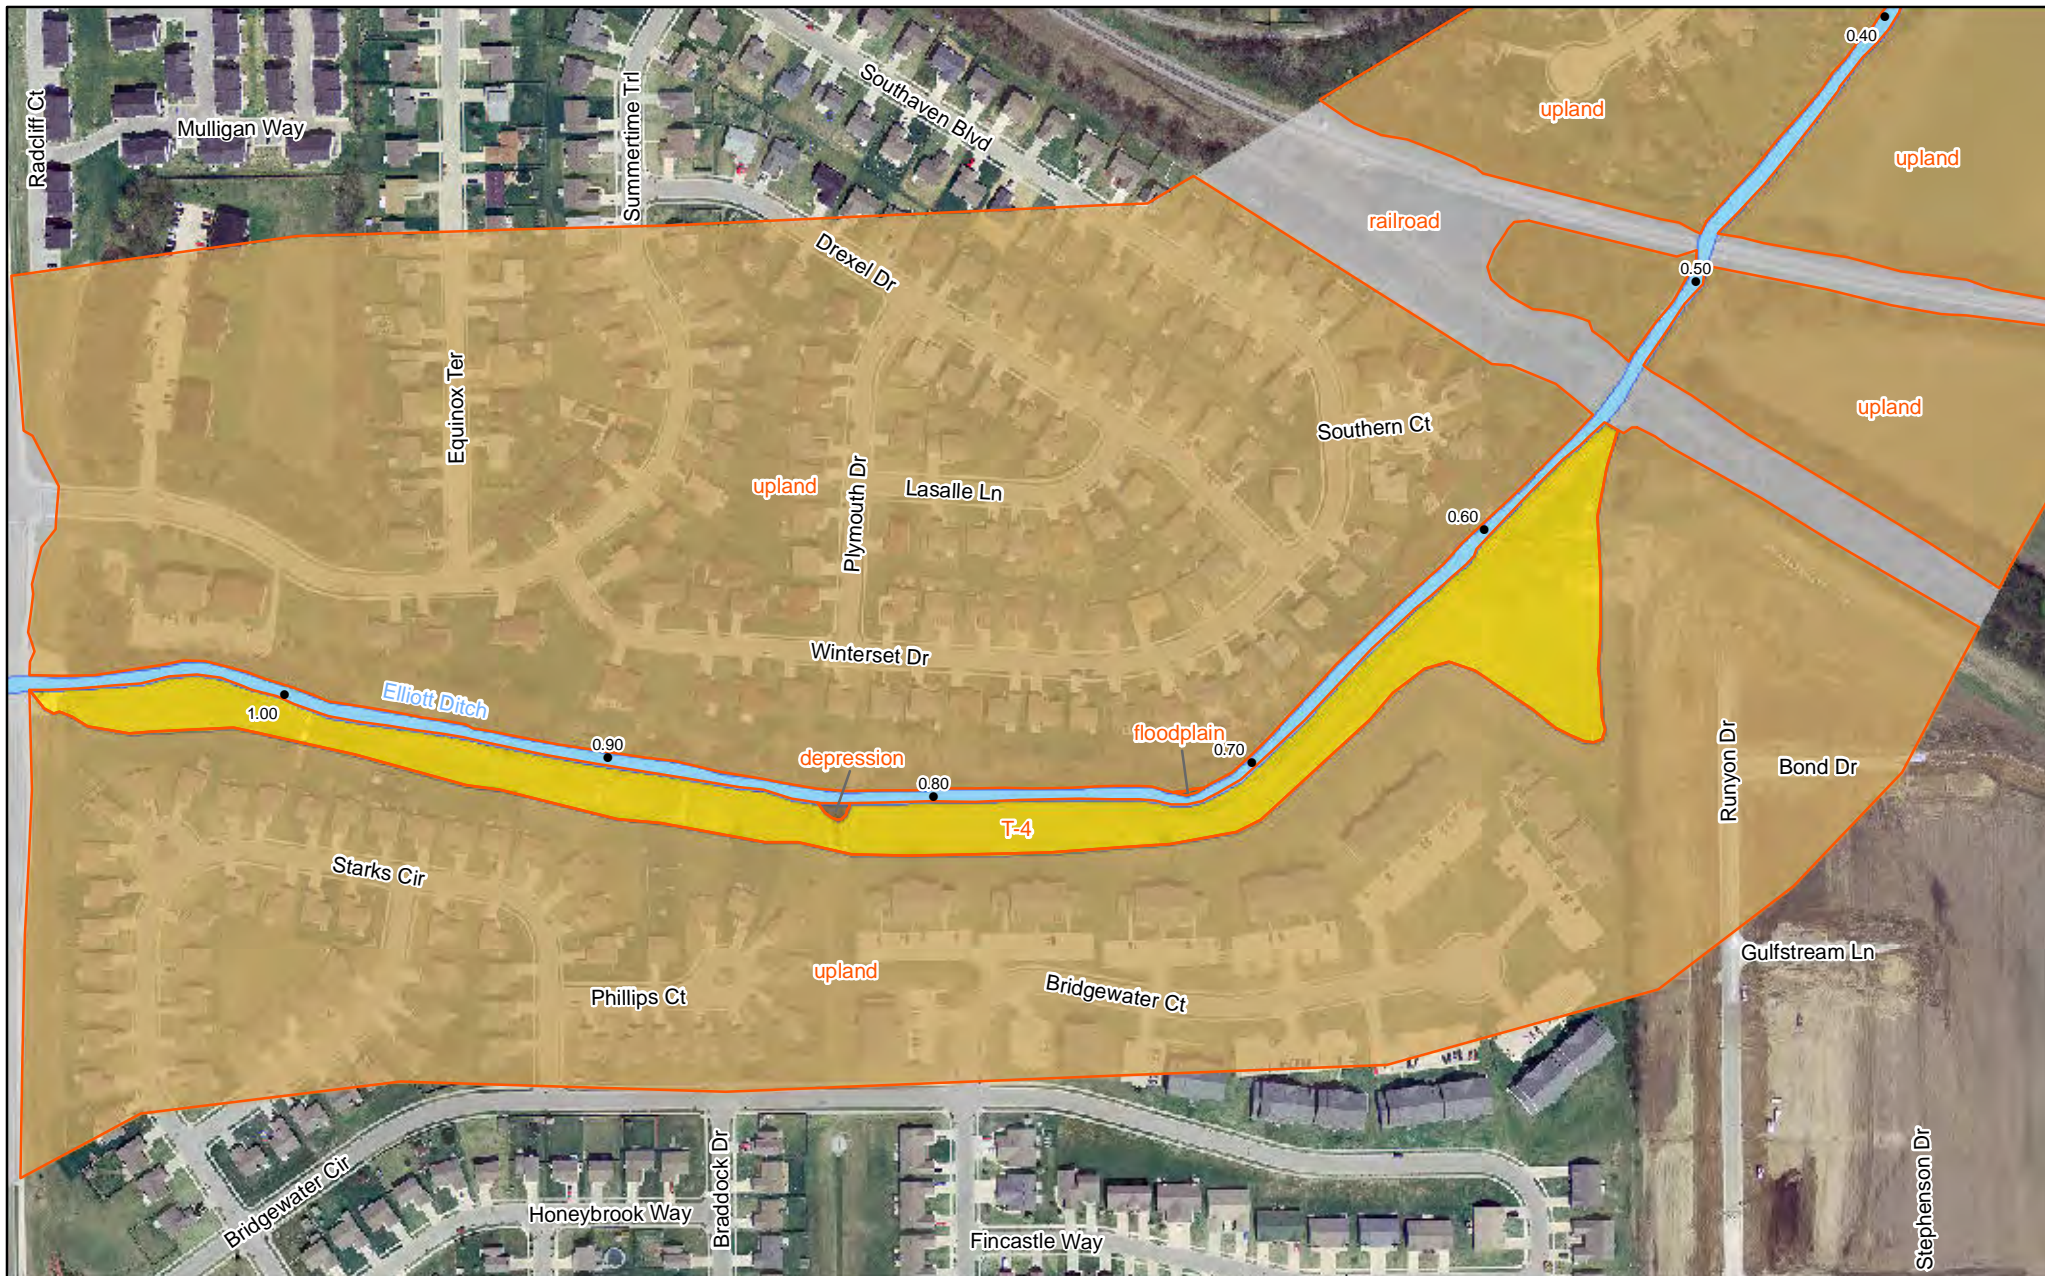
Figure 3

Geomorphic Surfaces

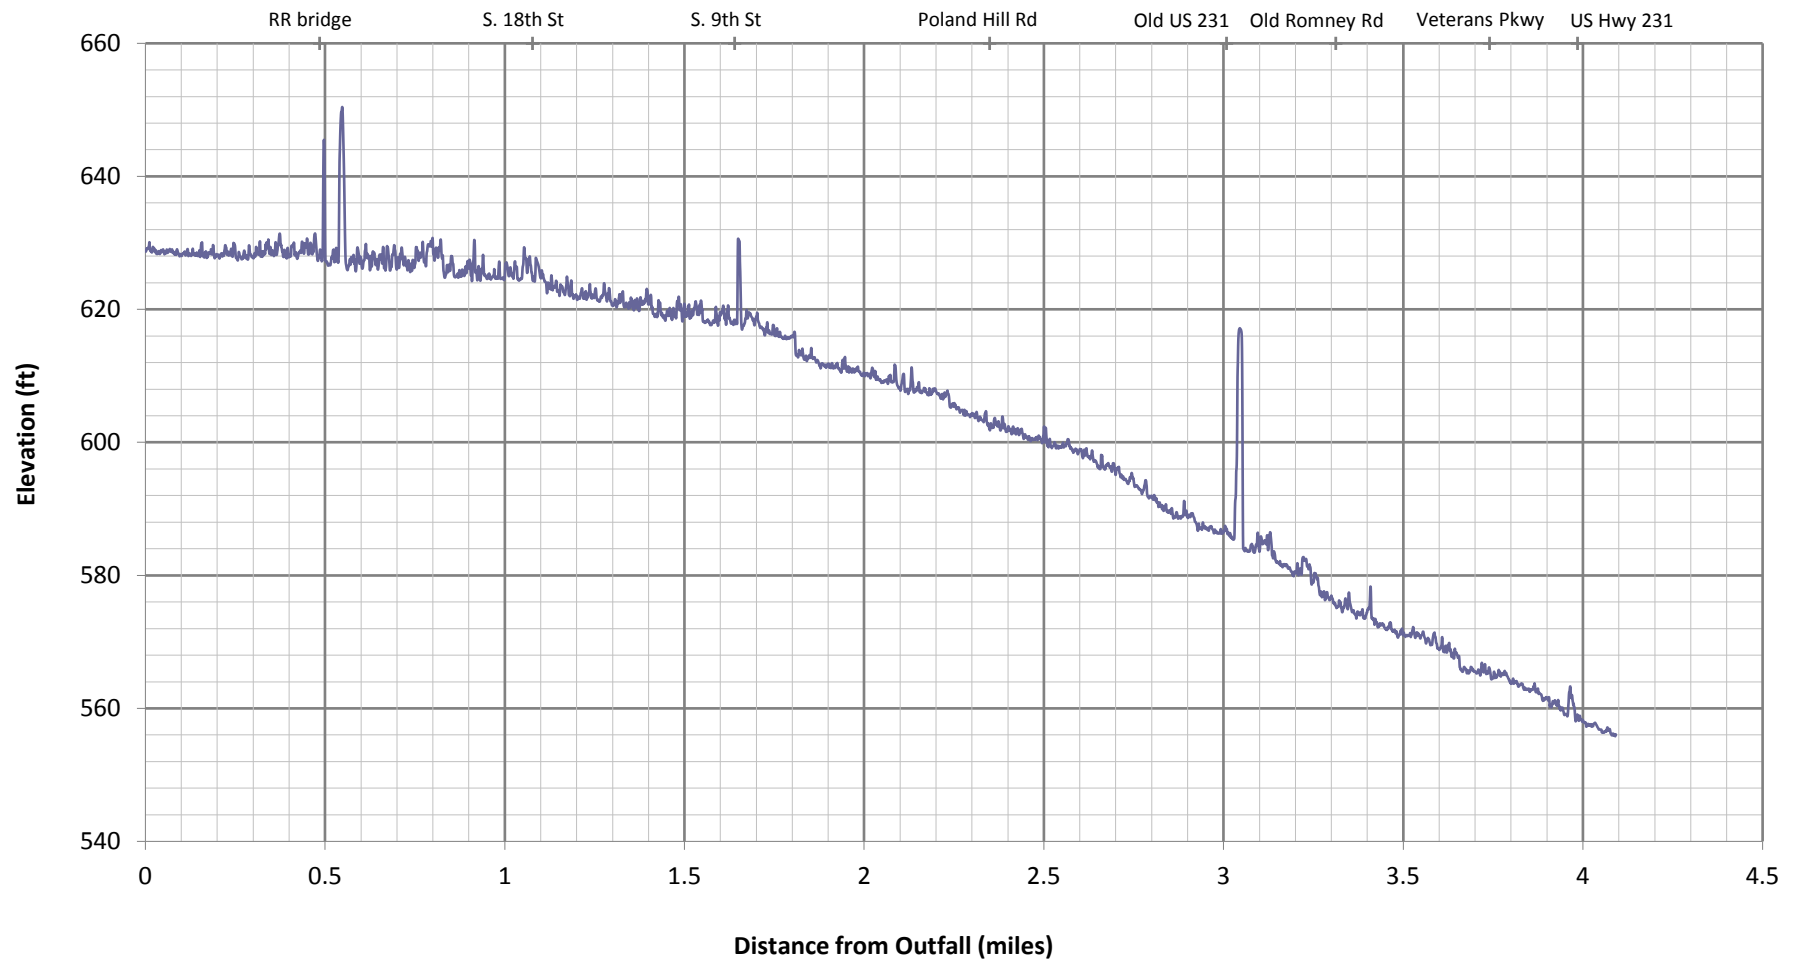
Elliott Ditch Longitudinal Profile - *Outfall 001 to Confluence with Wea Creek*

Reach 2 of Elliott Ditch is characterized by a straight channel and a steeper channel gradient of approximately 8 feet/mile (Figure 4, Appendix A). The north side of the channel is upland, but the south side has a preserved T-4 terrace adjacent to the ditch. Deposition in this reach may occur on the T-4 terrace after large flood events and locally in-channel associated with pools.

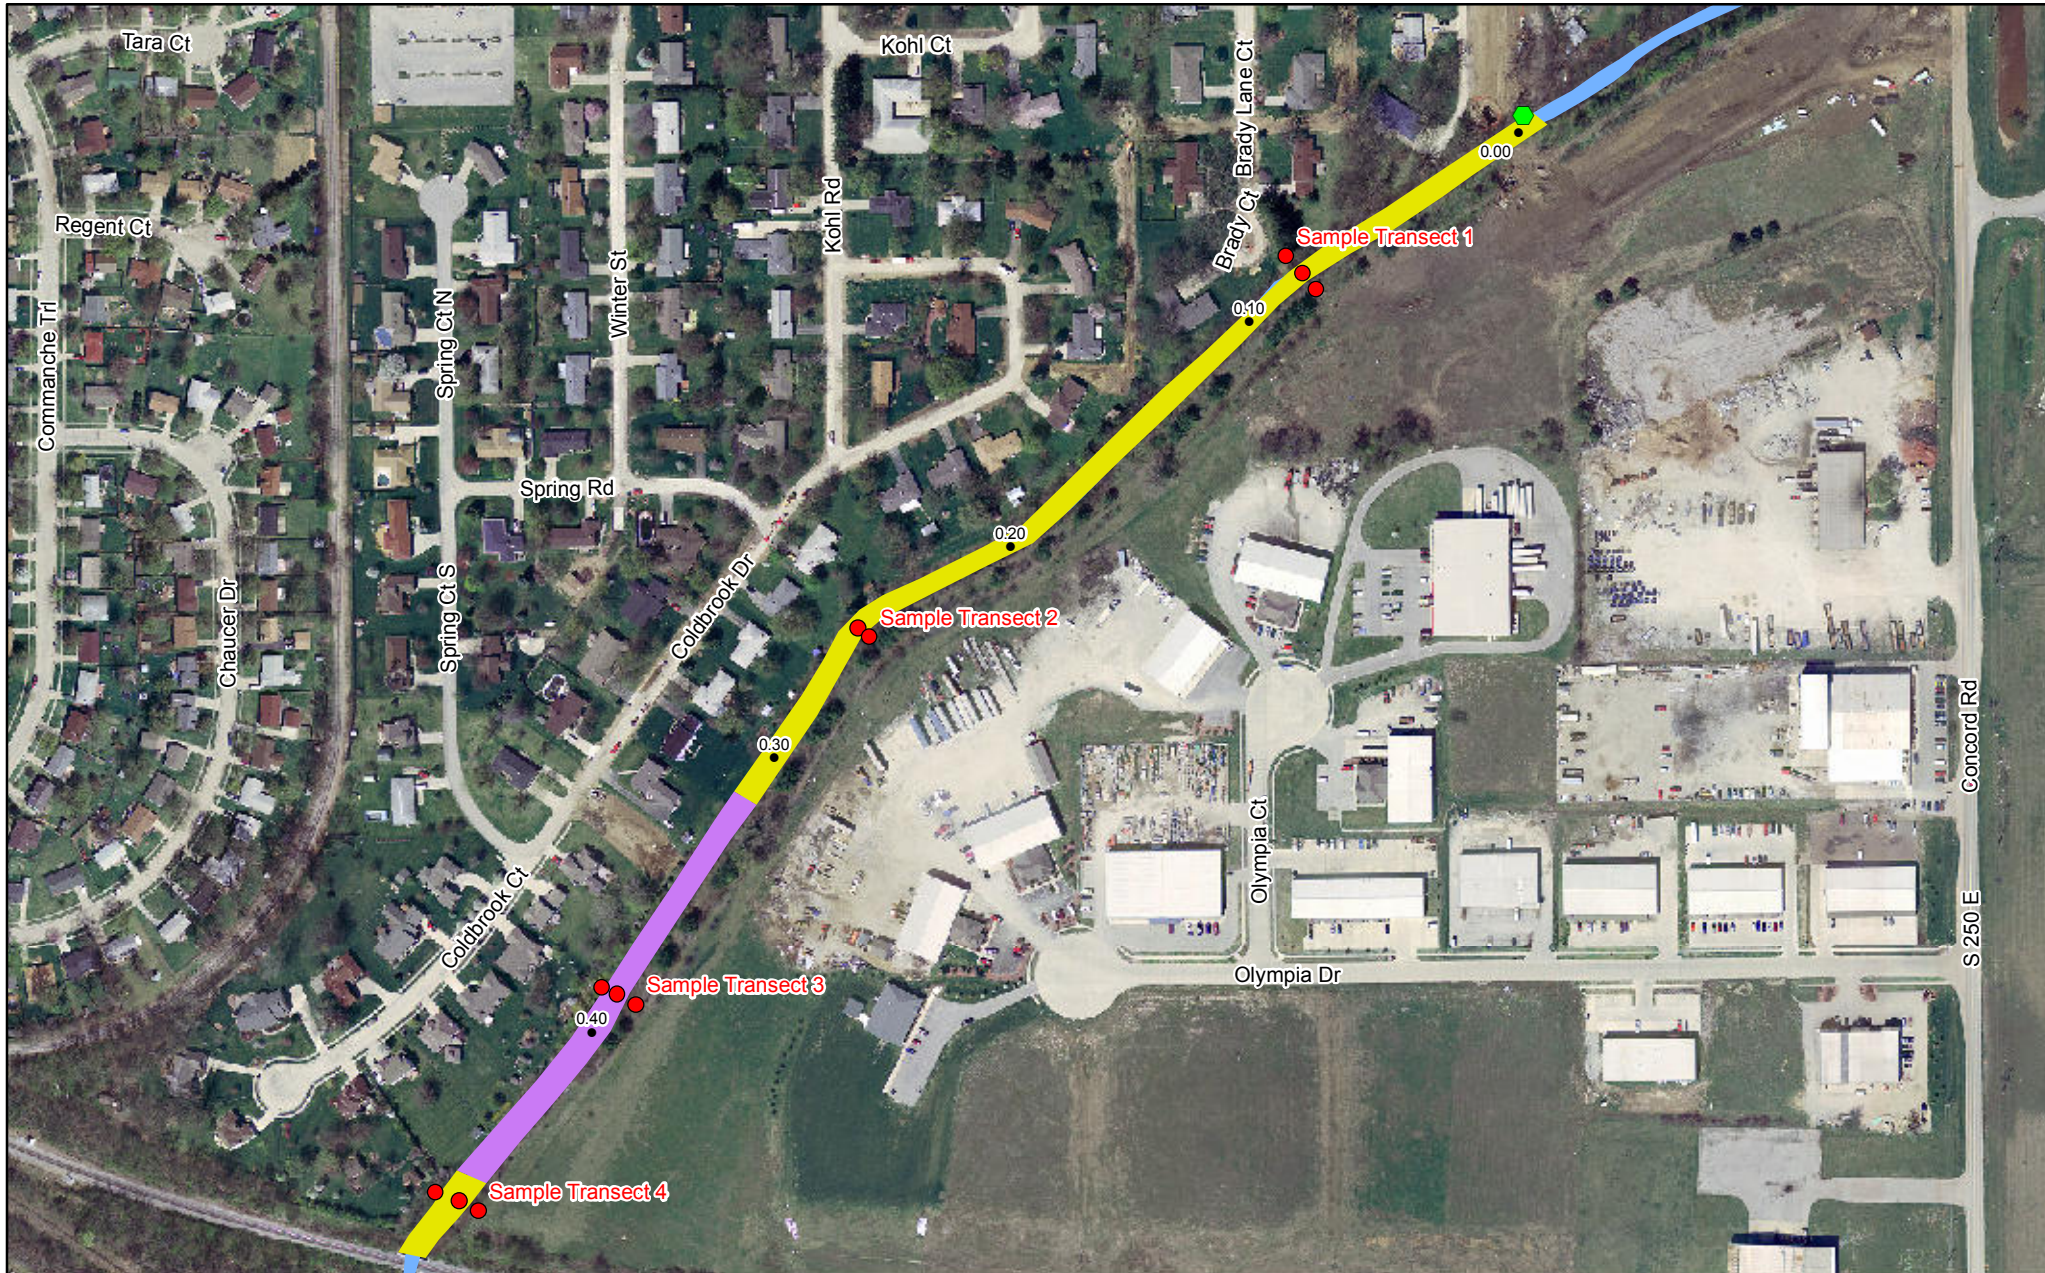
Figure 5

Example Proposed Sample Locations and Erosion/Deposition Surfaces

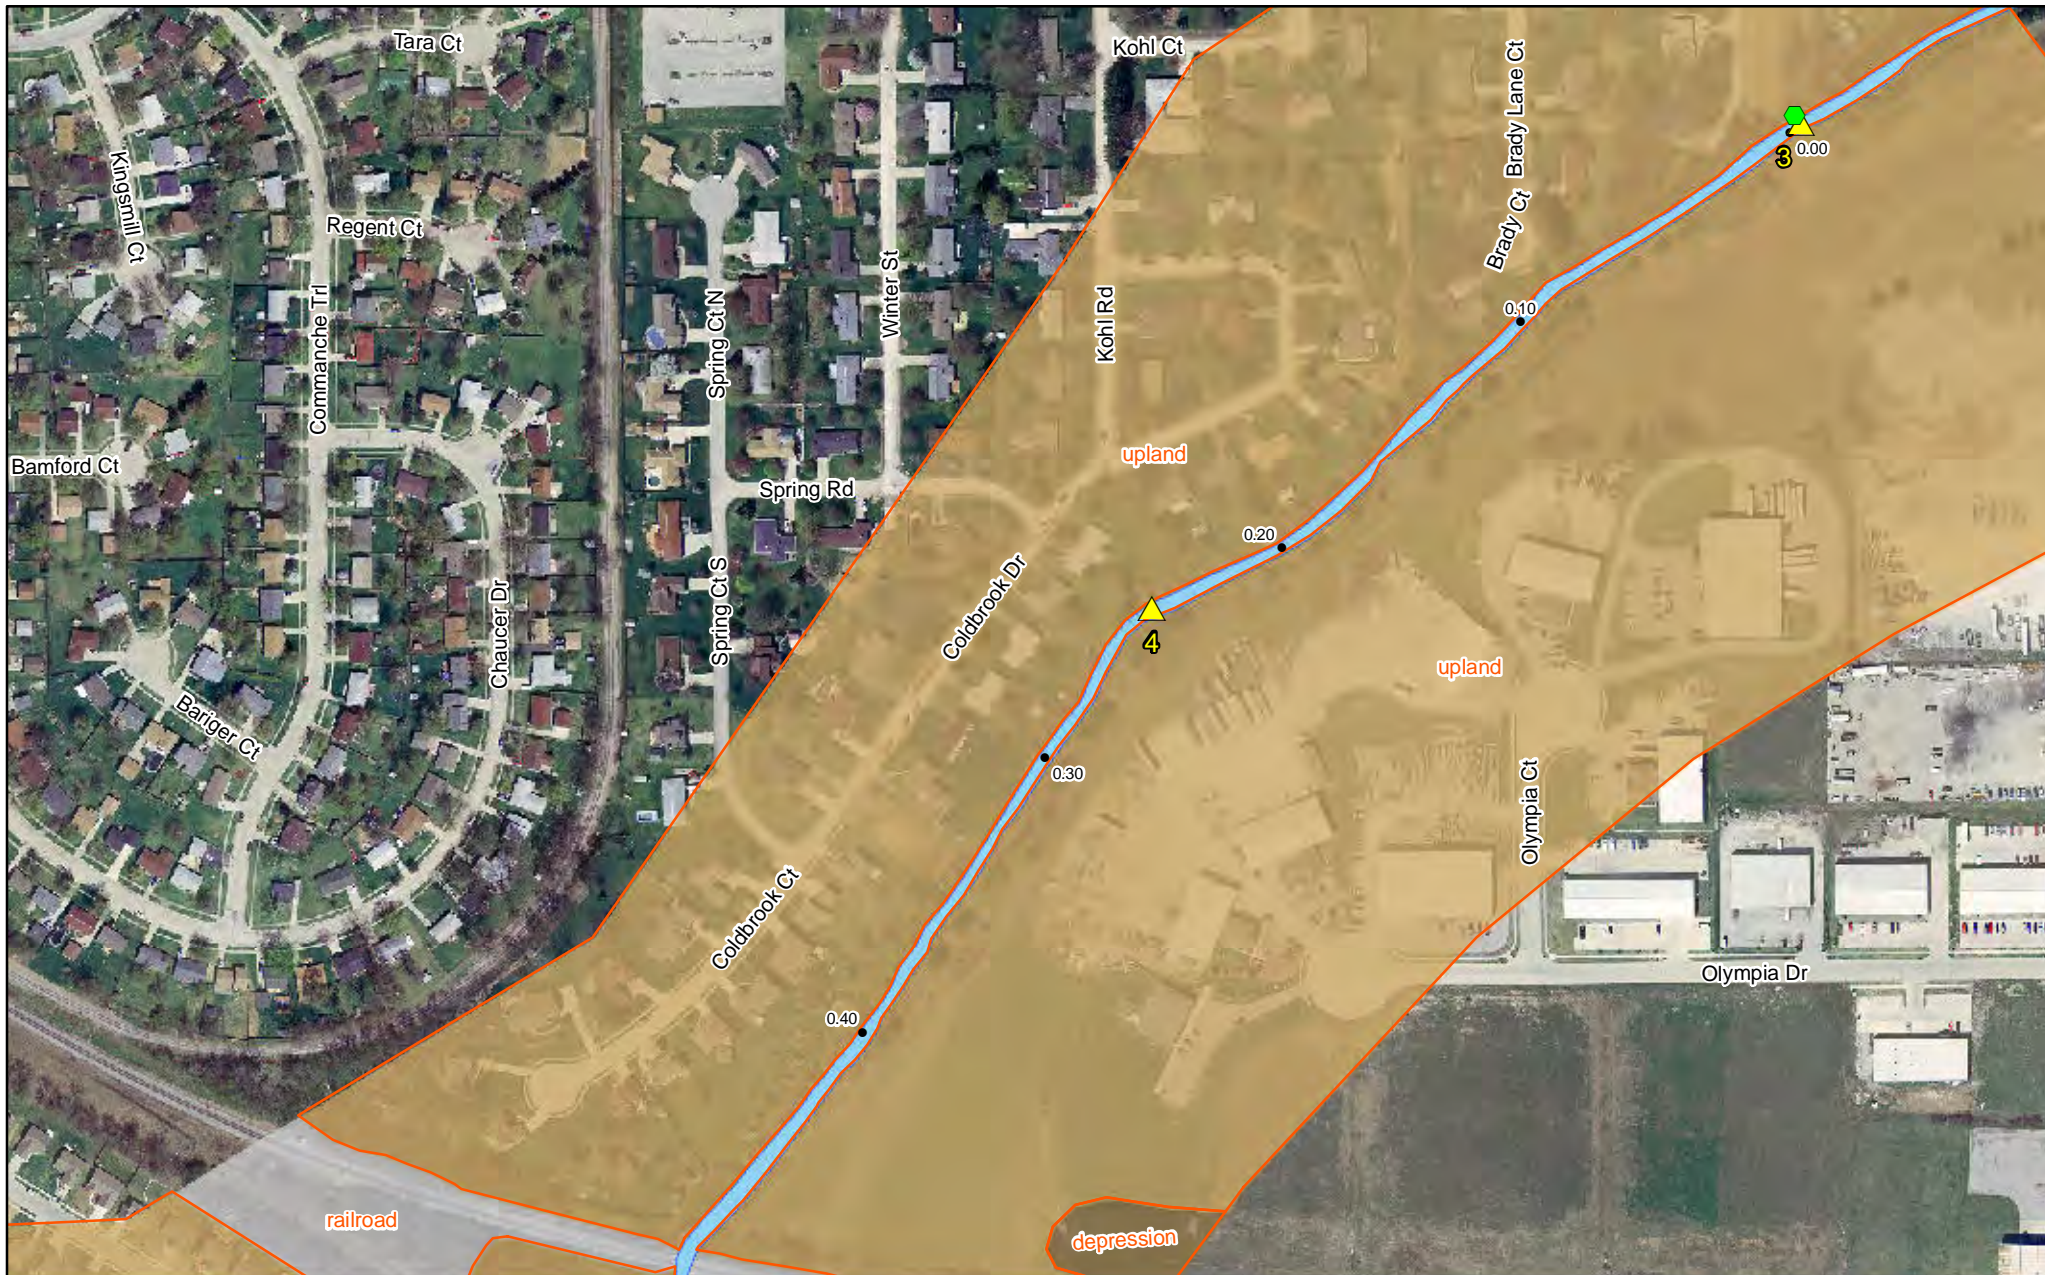
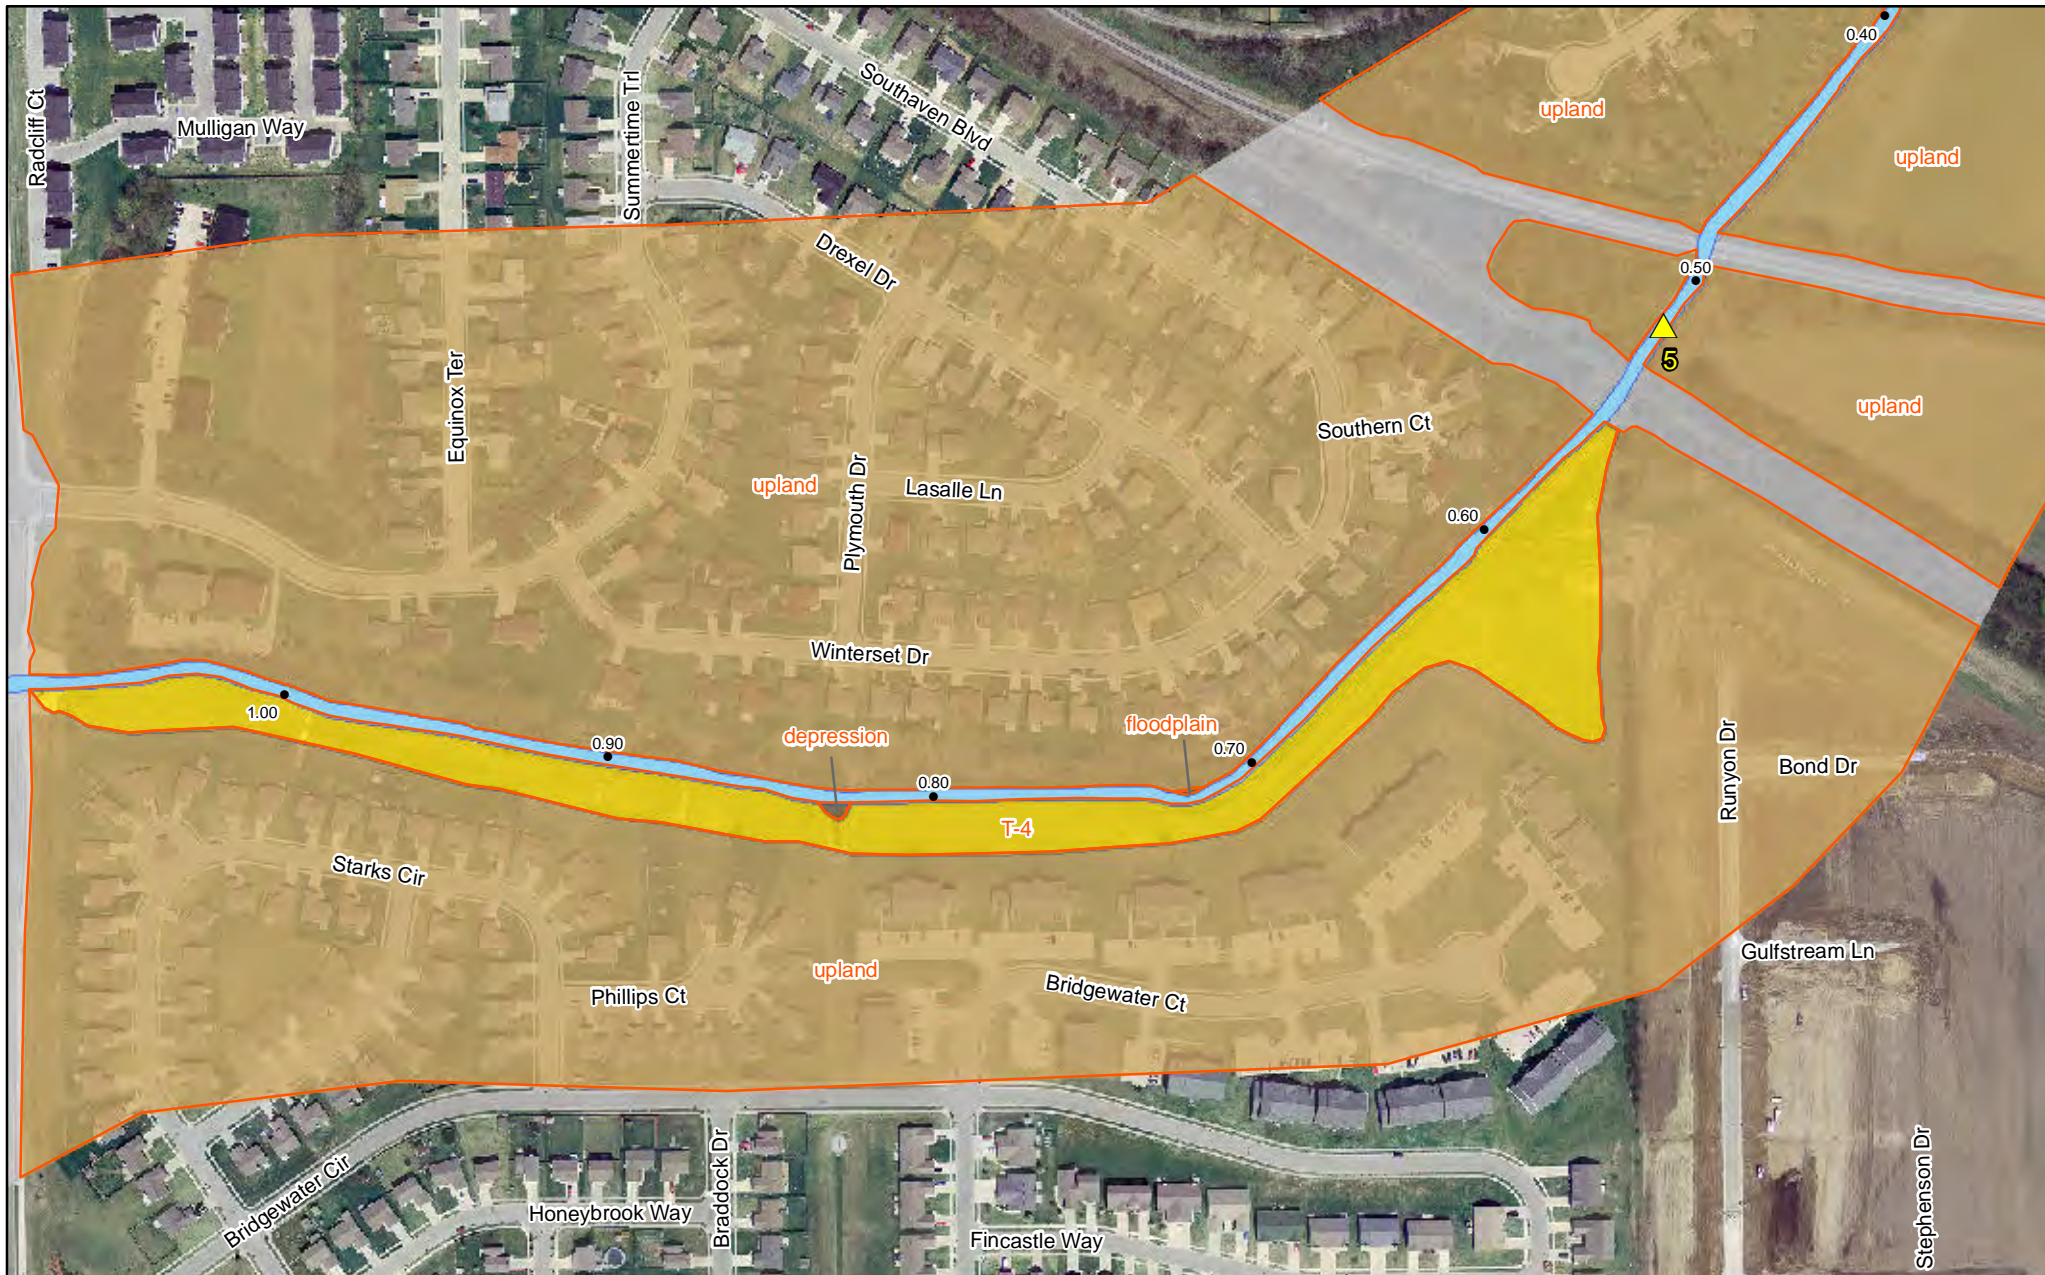
Figure 6

Anchor Sample Stations and Geomorphic Surfaces

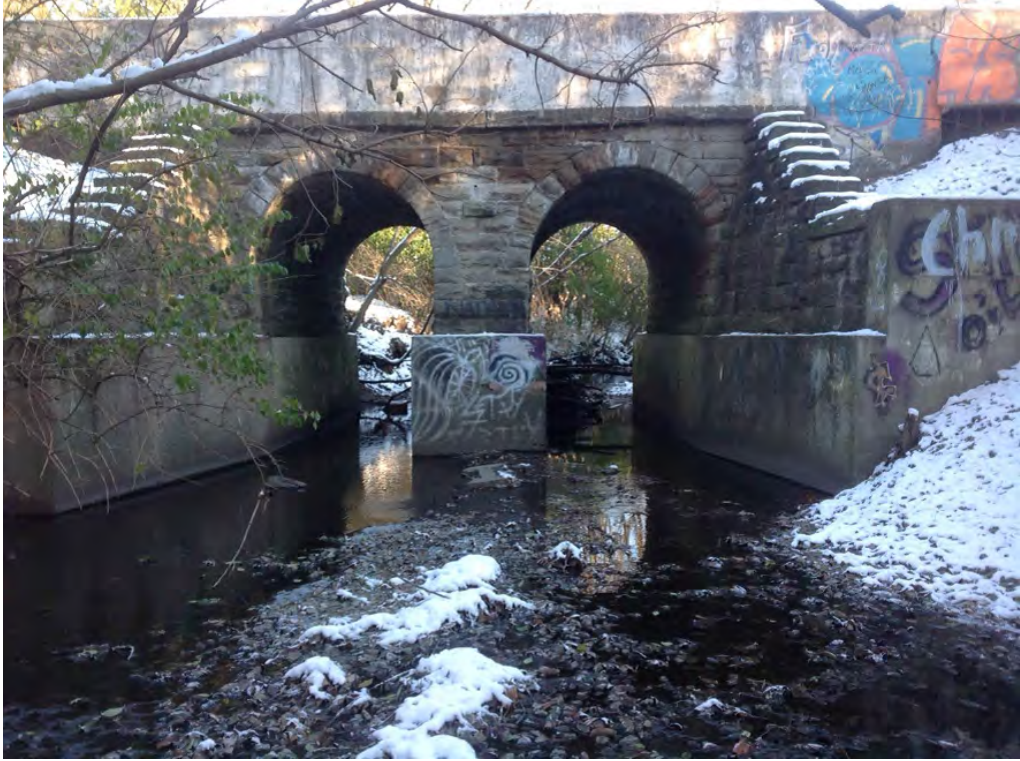
Photo 3: Looking upstream at active railroad bridge between transects 12 and 13. Stream bed consists of sand, gravel and cobbles. Poured concrete floor under bridge arches is completely exposed on RDB side bridge arch.

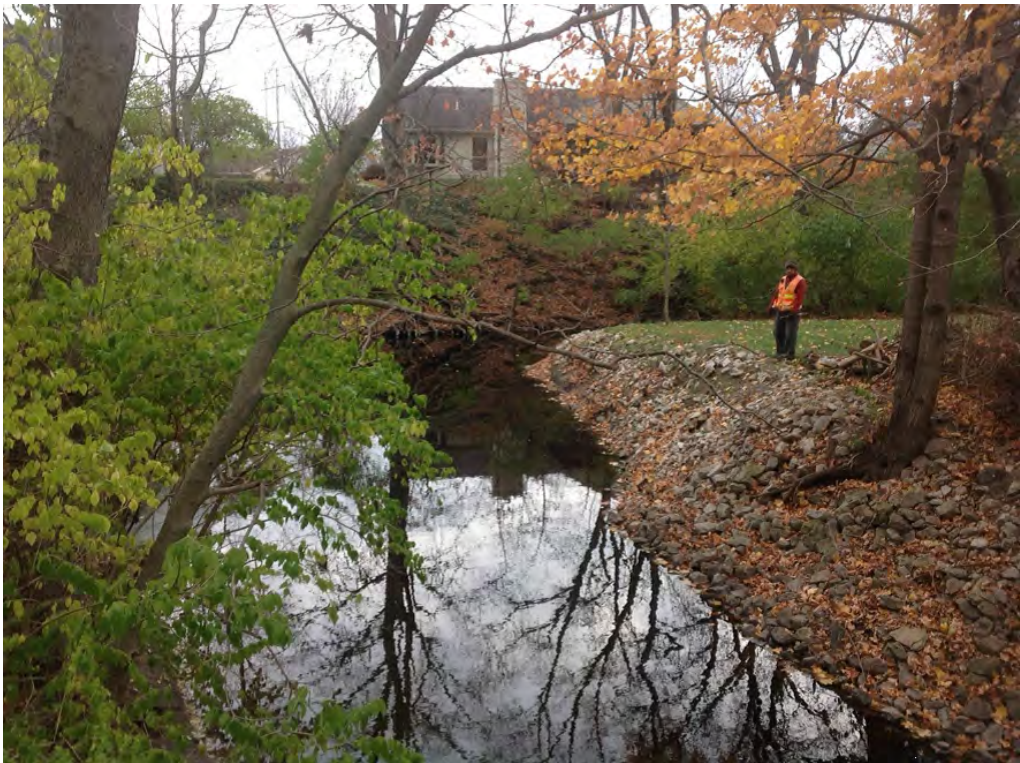
Photo 4: Looking downstream at transect 35. Person is standing on T-6. House in background is sitting on the upland.

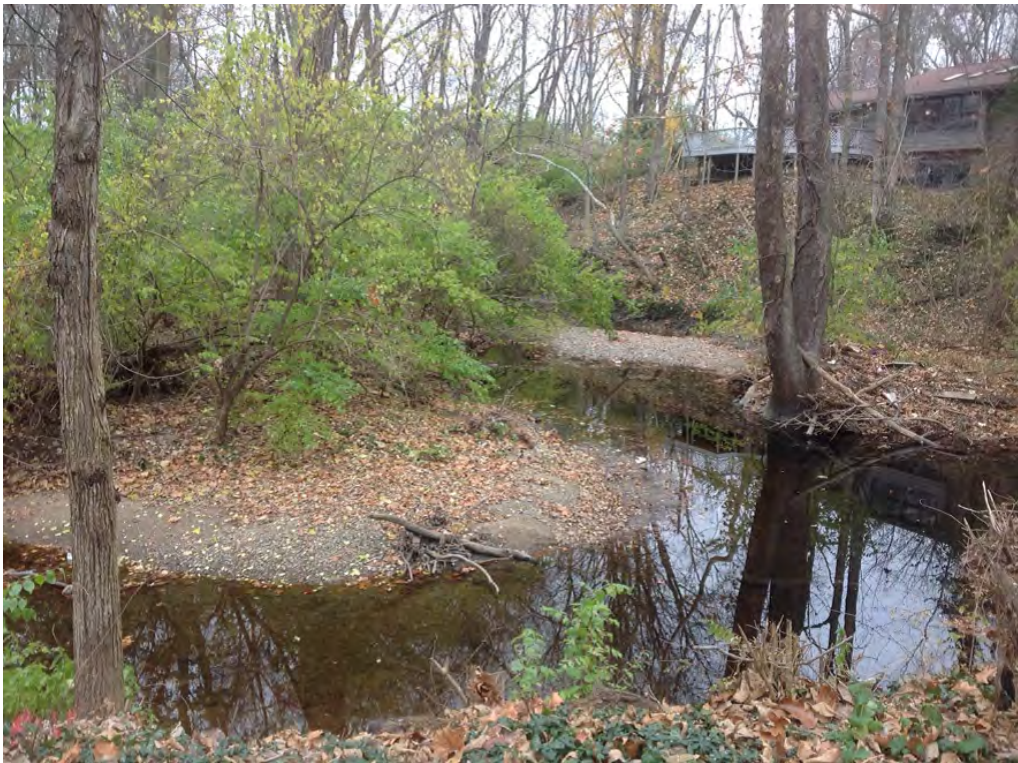
Photo 8: Looking downstream near transect 39. Point bar in foreground has T-1 (bare gravel & leaf litter), T-2 (single tree), T-3 (exposed tree roots). Flood debris (garbage) is visible on the T-2 surface on the right of the photo. The house is sitting on the upland surface.
