**Elliott Ditch Geomorphic
Surface Mapping and Historic Data Review
July 6, 2015**

Prepared for Alcoa

**Prepared by Tetra Tech CES
Submitted: July 6, 2015**

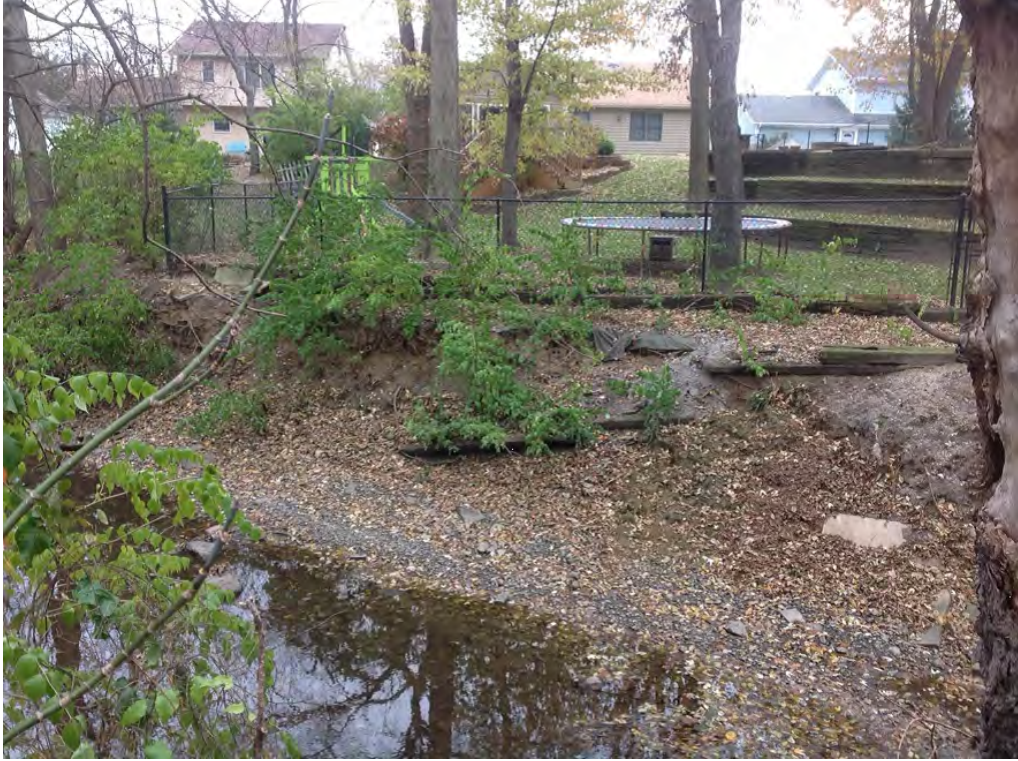
Photo 9: Looking at LDB near transect 25. Gravel surface in foreground is the floodplain. The trampoline is on the T-6 and the houses are located on the upland surface.

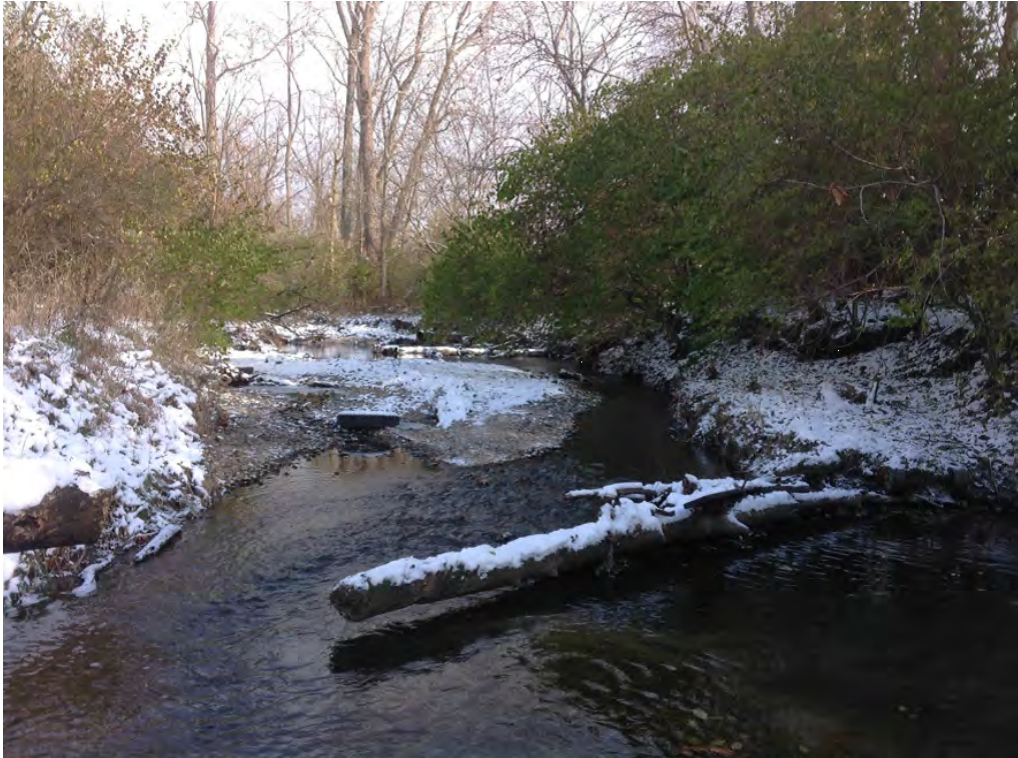
Photo 10: Looking upstream near transect 65. The sand and gravel surface in the middle of the photo is the floodplain. The T-1 is located on the right of the photo at one end of the protruding log. The T-2 is covered by trees and shrubs on both sides of the channel.
