**RCRA CORRECTIVE ACTION  
INTERIM MEASURES WORK PLAN  
ELLIOTT DITCH – REACHES 1-3 SEDIMENT  
& ISOLATED SOIL REMEDIATION**

**ARCONIC LAFAYETTE OPERATIONS  
3131 EAST MAIN STREET  
LAFAYETTE, INDIANA 47905**

**CEC PROJECT: 172-367.0014**

**JUNE 2020**

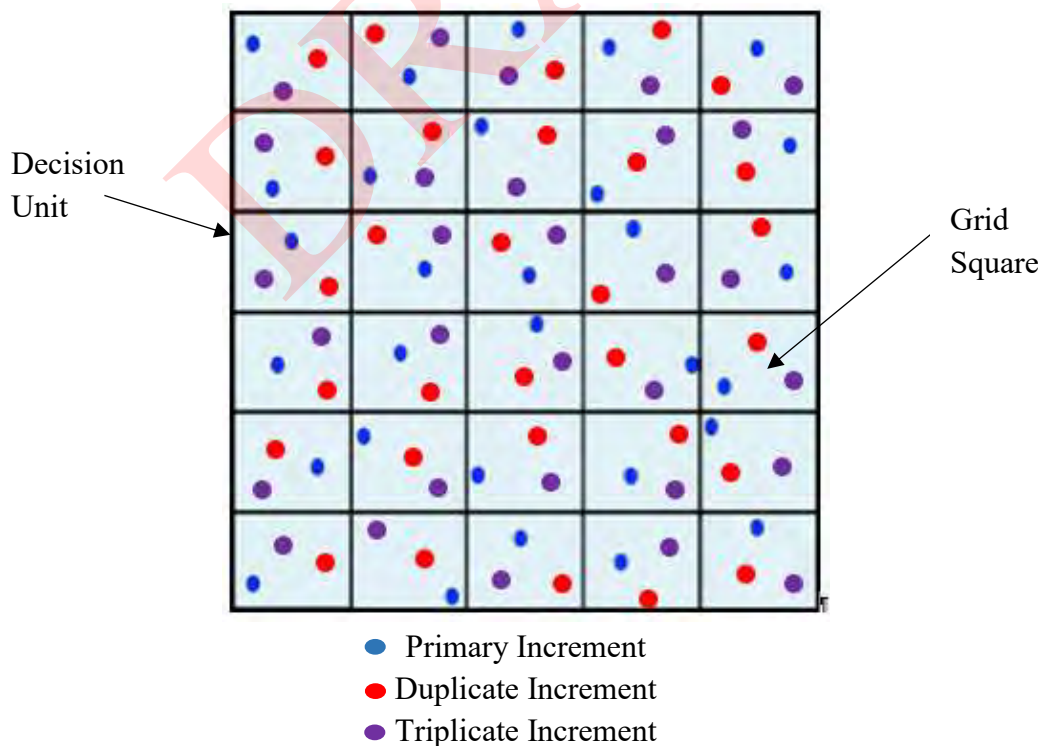
**Illustration – Example Primary, Duplicate, & Triplicate Incremental Samples  
Increment Collection Locations in Grids Using Random Sampling Approach**

1.0 mg/Kg. The DUs are less than 0.1 acres, which for sediment removal in Reach 1 up stream of the railroad tracks, will assist in expediting the excavating, sampling, and backfilling process. This should provide flexibility to the IM Project and limit the number of open DUs that could be exposed to a precipitation event, particularly flooding conditions. The other DUs are based on the size and shape of the geomorphic features that are targeted for remediation. As noted previously, the upland soil excavation area at Milepost 00.51 is subject to change based on confirmation sampling results. The number of DUs in the final excavation area will be based on the delineated area and subjected to a maximum area of 0.1 acres. Confirmation sampling at DUs 1 through 29 will be conducted following the ISM. To determine the number of composite points, or increments, per DU, the coefficient of variation (CV) was calculated using the data in **Table 1**. The CV was calculated separately for sediment and soil at 1.54 and 1.67, respectively; therefore, per the ISM, 20-31 increments and  $\geq 3$  replicates (i.e., primary, duplicate, and triplicate samples) are required for sediment and soil DUs. The sampling method within each DU will be random sampling within grids, where the number of grid squares is equal to the number of increments. Each grid will be approximately the same square footage, but not necessarily the same shape due to the irregularities of the geomorphic surfaces and the stream channel. The sample, duplicate, and triplicate increments will be collected from within a grid location at random while maintaining at least 3 feet of separation from one another. Please refer to the illustration in the following depicting the layout of the primary, duplicate, and triplicate increments within the DUs.

The perimeter of the grids making up each DU will be located and marked using a real-time kinetic (RTK) GPS unit or similar. Increments will be collected using a 1-inch diameter barrel sampler, or similar, advanced to 3 inches below the bottom of the excavation with a slide hammer, such that the recovered increment volume is consistent between locations. Should refusal be encountered without reaching 3 inches in depth, the increment location will be offset and sample collection retried. This procedure will be followed until adequate soil recovery is retrieved in the sampler. The soil and sediment from the individual increments obtained from each of the grids will be placed into laboratory provided glassware and appropriately labelled while wearing nitrile gloves. Processing of the individual increments and compositing into the incremental sample will be performed by the laboratory following the procedure described in **Section 4.5.2**. Each DU will include primary, duplicate, and triplicate incremental samples, i.e. three unique samples made up of different increments from each of the grids. Based on an estimated density of the targeted soil and sediment between 1.0-1.2 grams per cubic centimeter ( $\text{g/cm}^3$ ), individual soil increments will weigh approximately 40-50 grams, with the final incremental samples weighing approximately 800-1,550 grams. Upon collection, the increments will be placed into laboratory provided containers, labelled, and stored in a cooler on ice for shipment to the laboratory under proper chain-of-custody control. Increment processing in support of preparing the incremental sample is as described in **Section 4.5.2**. An example illustration of the random sampling within grids approach is provided in the following.

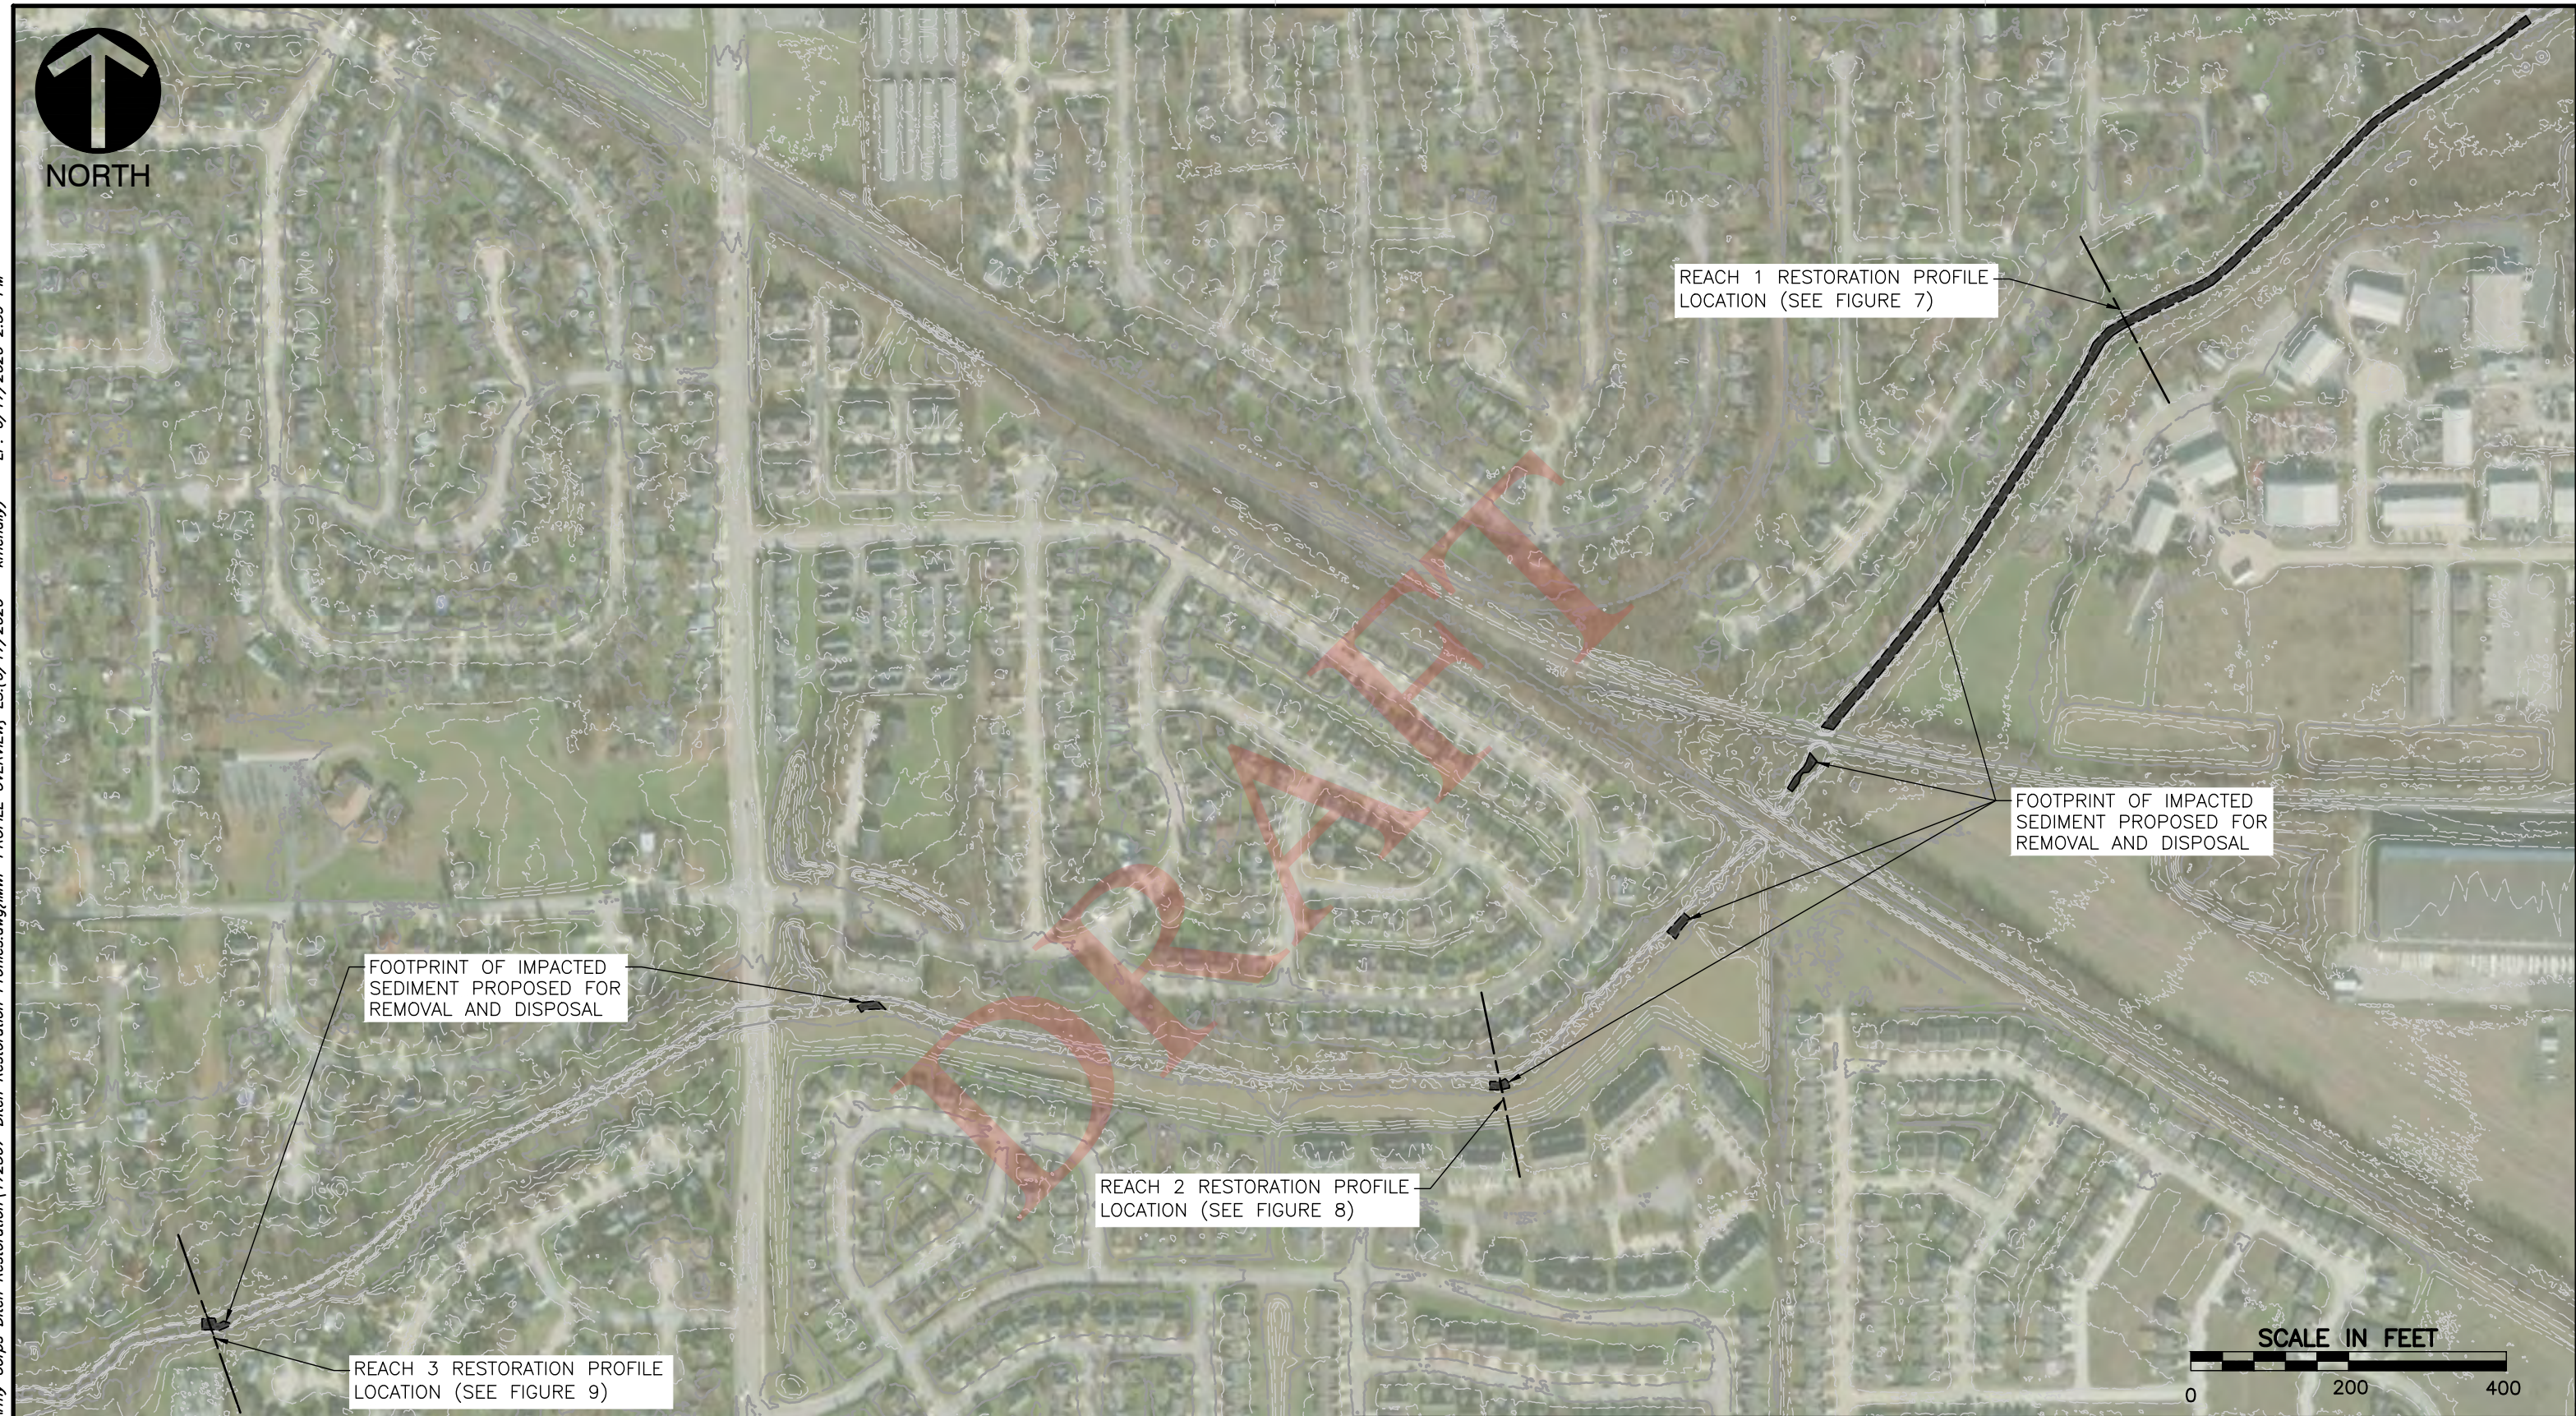
REACH 1 RESTORATION PROFILE LOCATION (SEE FIGURE 7)

FOOTPRINT OF IMPACTED SEDIMENT PROPOSED FOR REMOVAL AND DISPOSAL

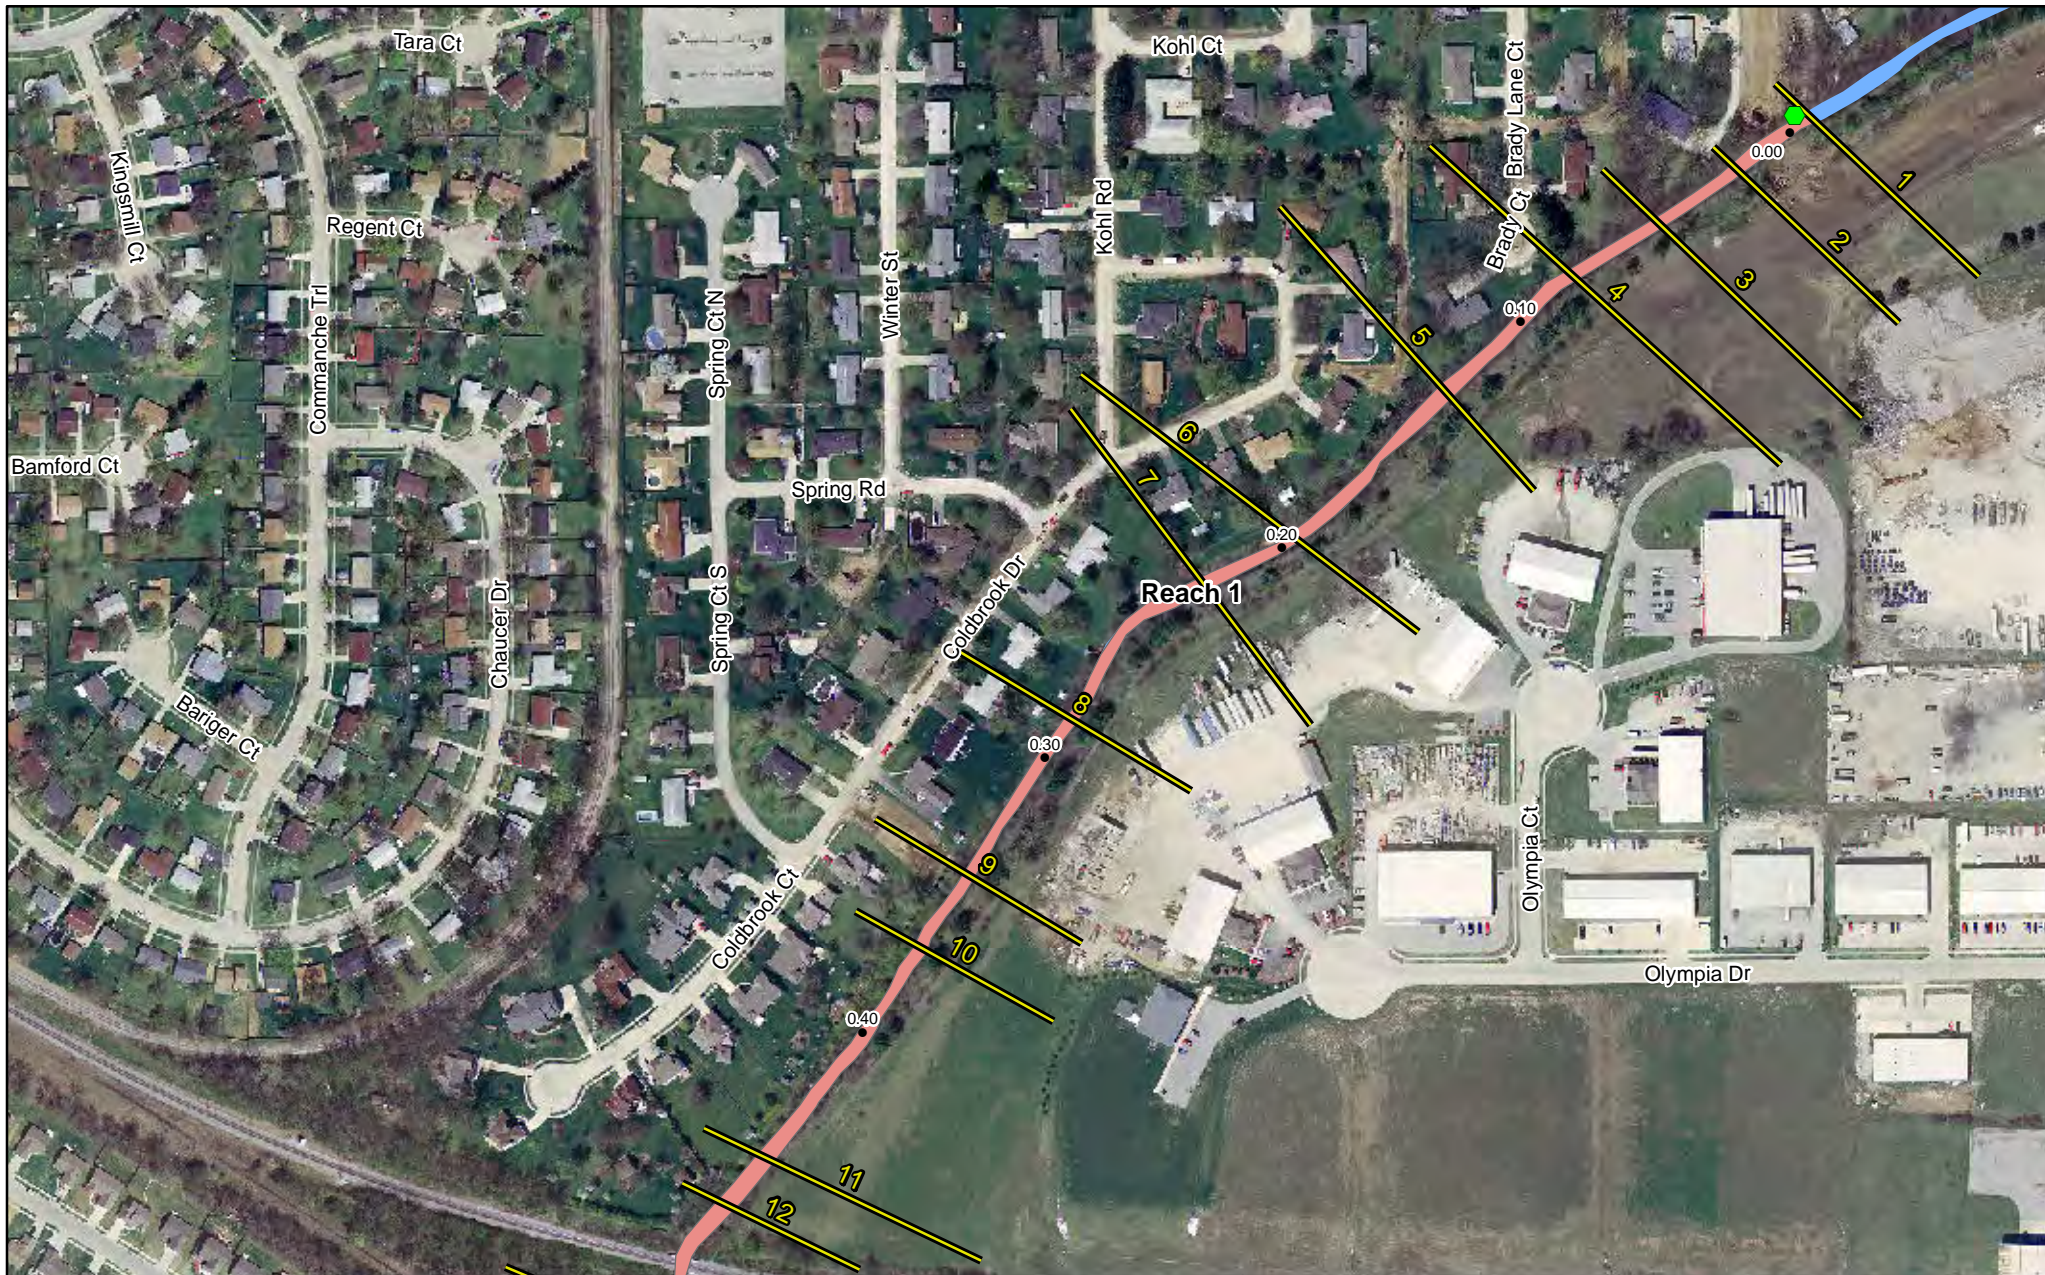
### **Figure 2**

Stream Reaches and Survey Transects

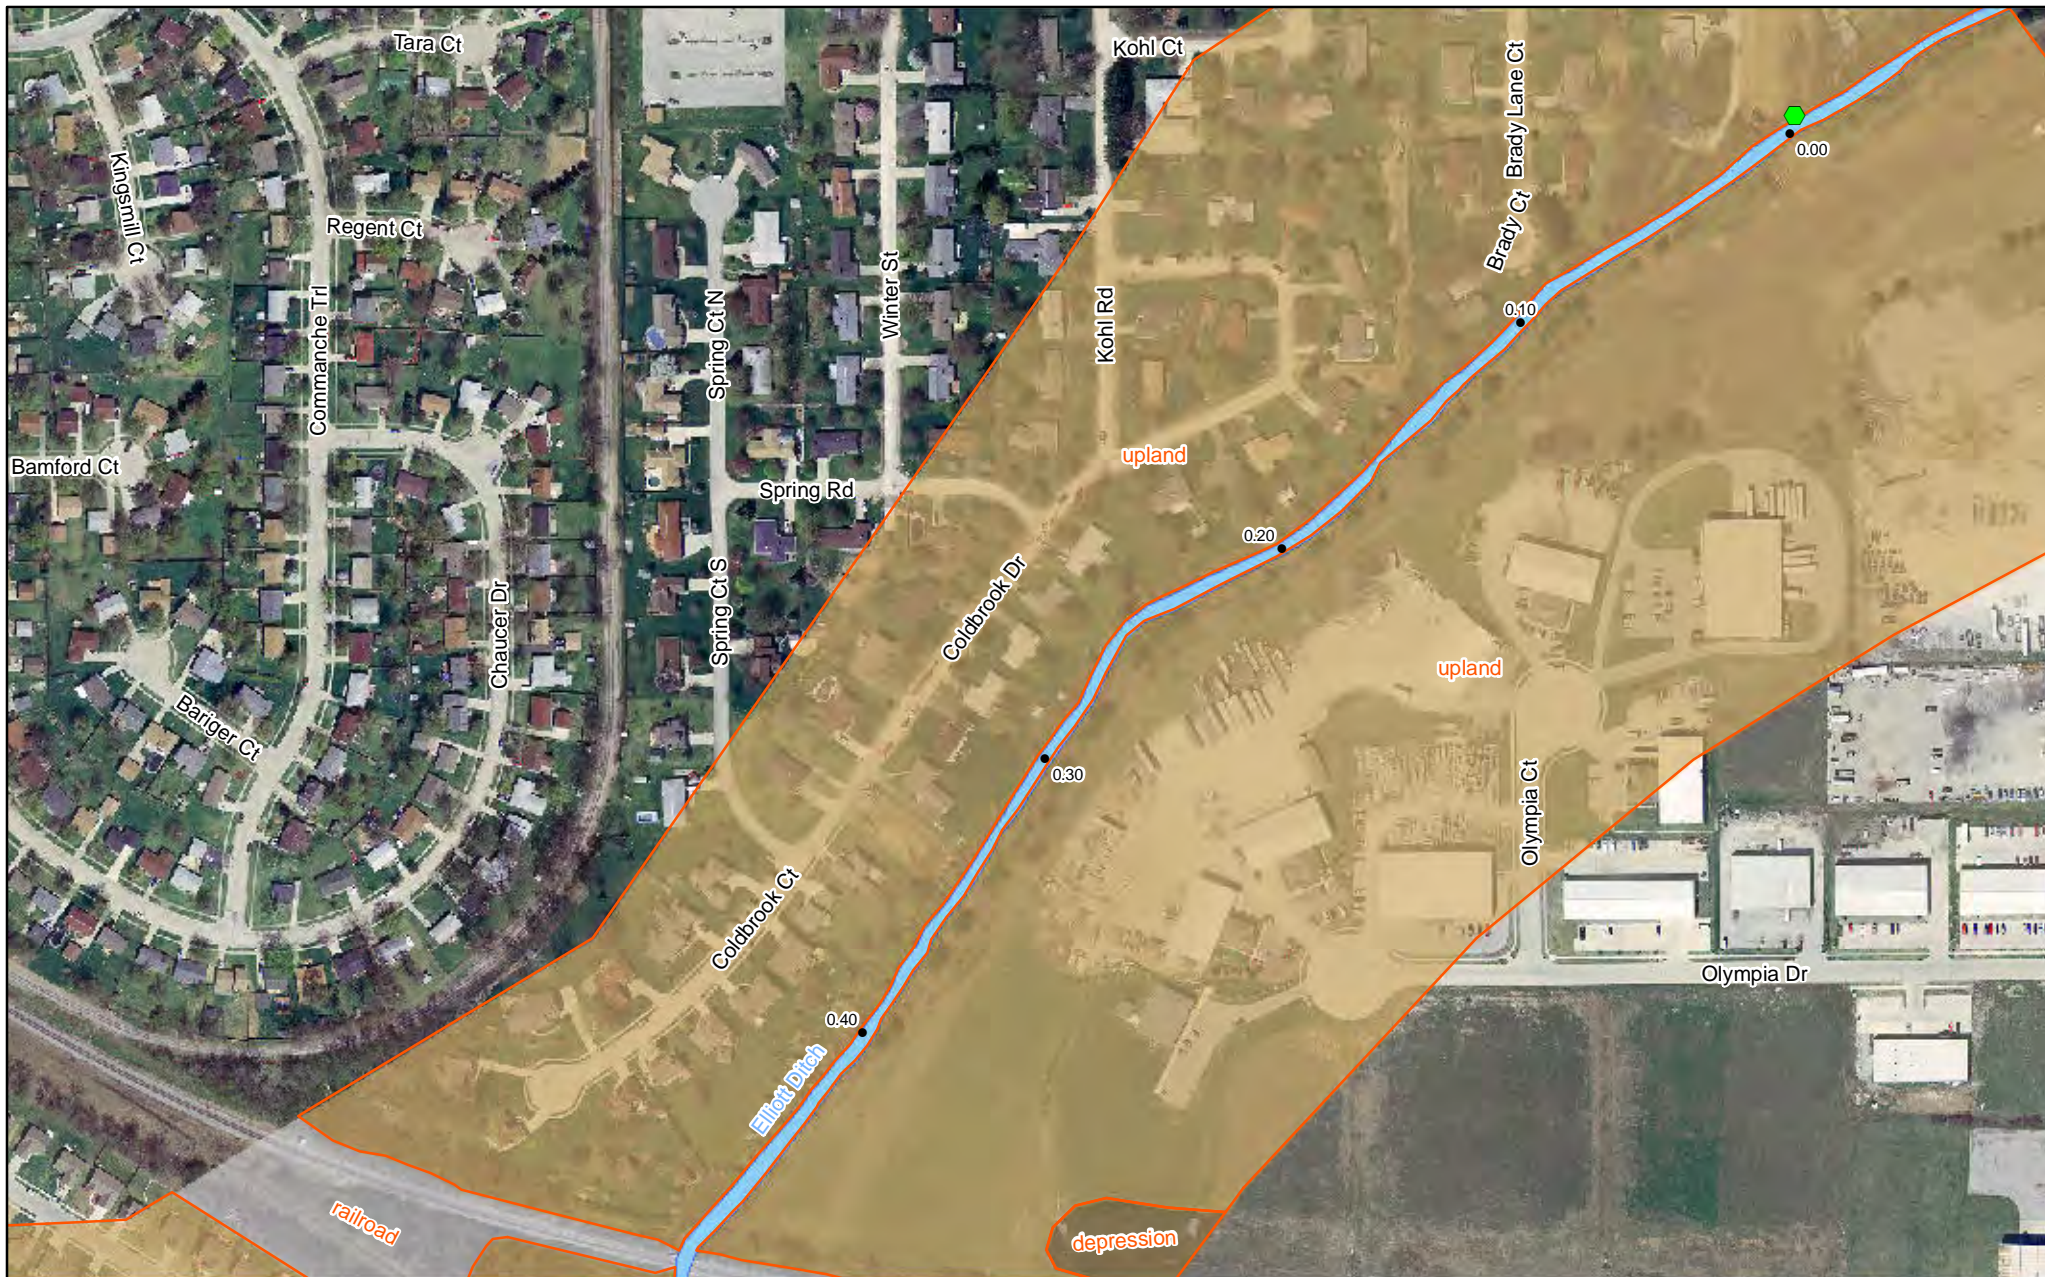
### **Figure 3**

Geomorphic Surfaces

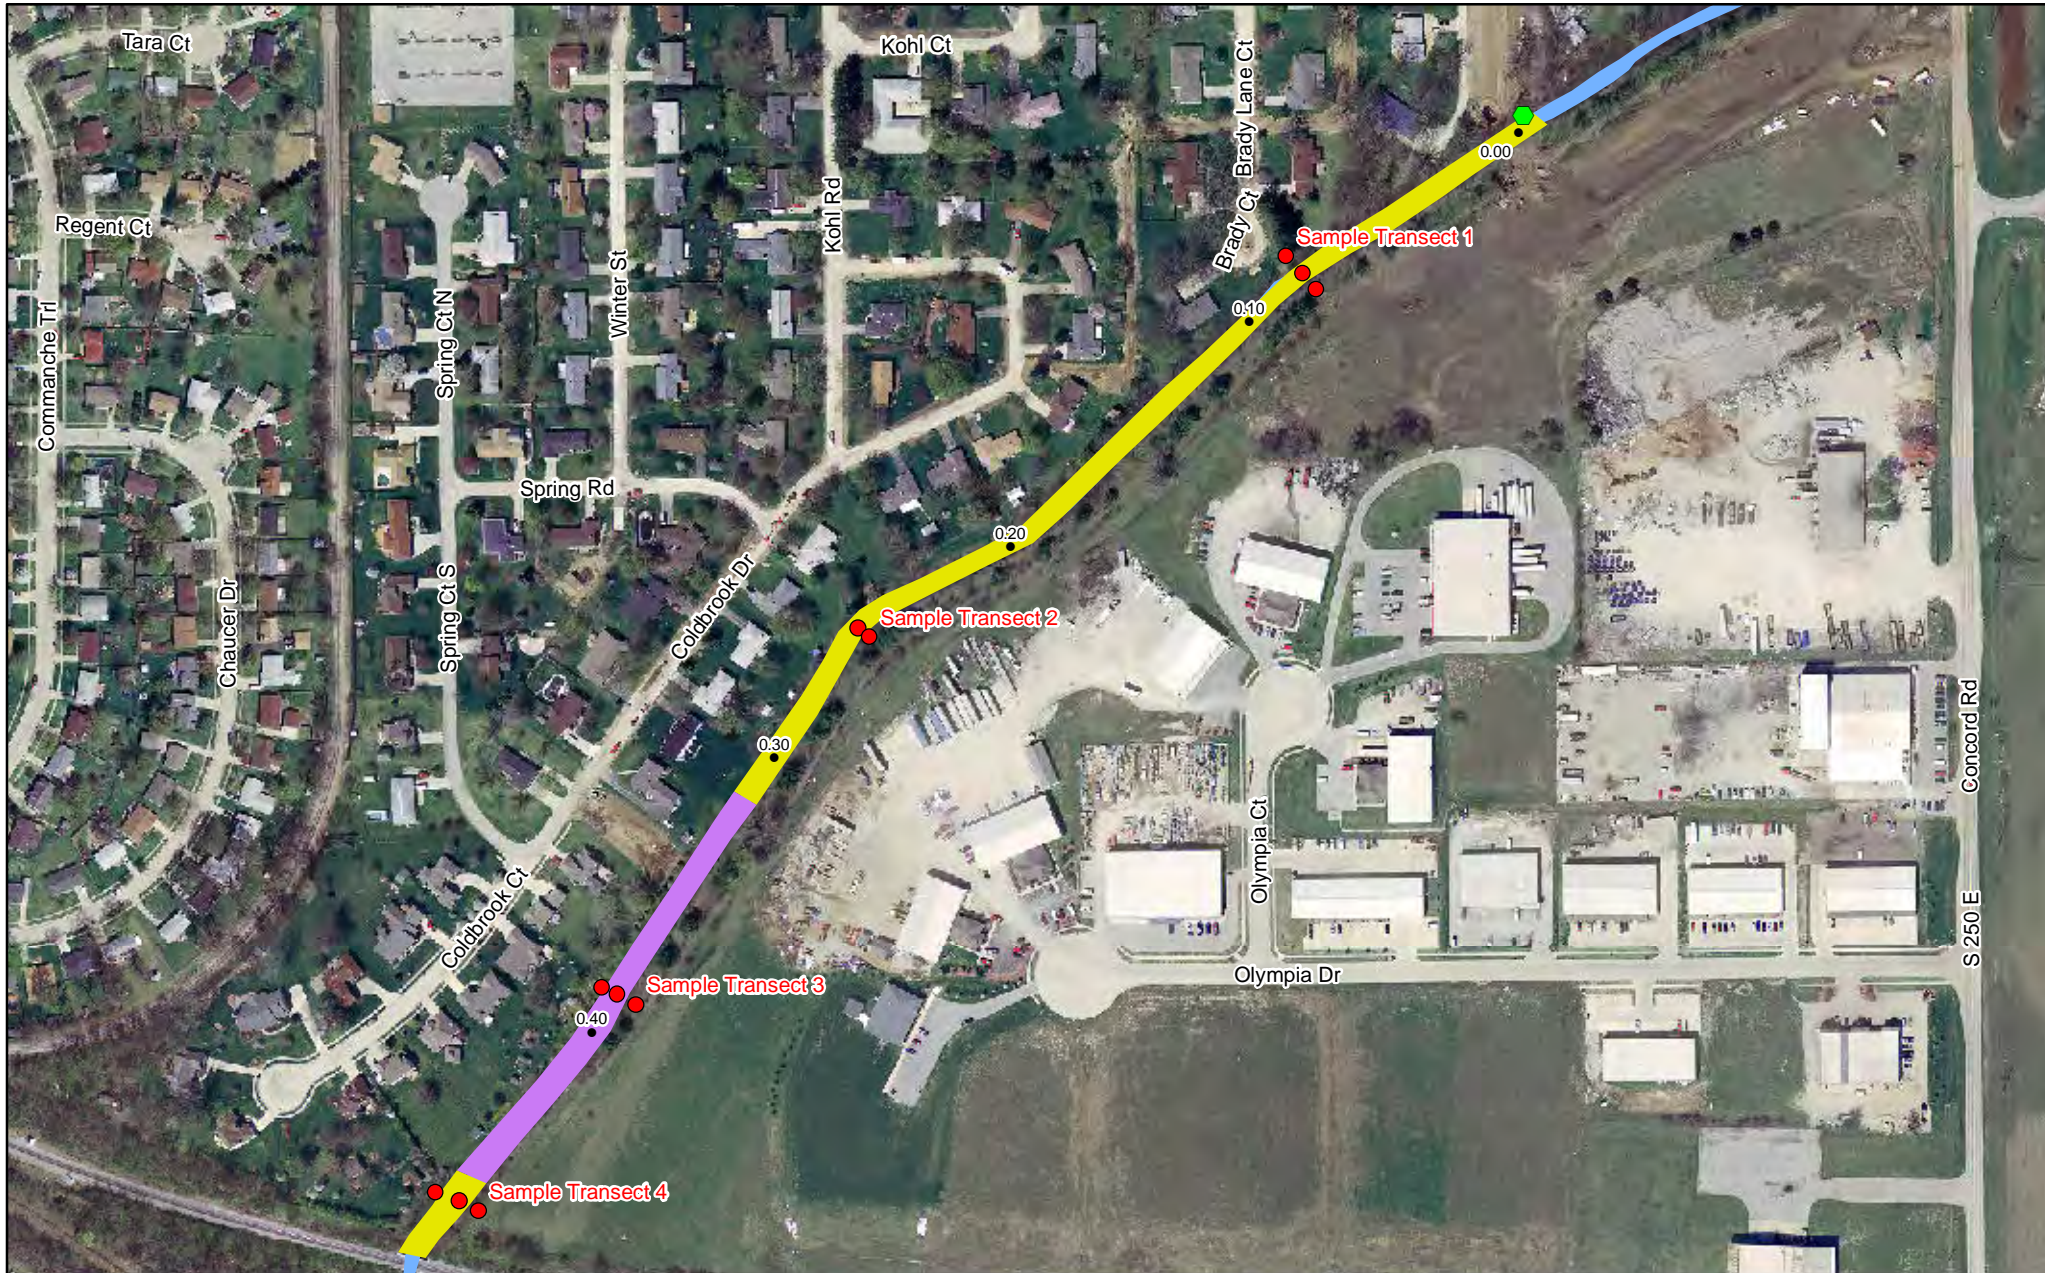
### **Figure 5**

Example Proposed Sample Locations and Erosion/Deposition Surfaces

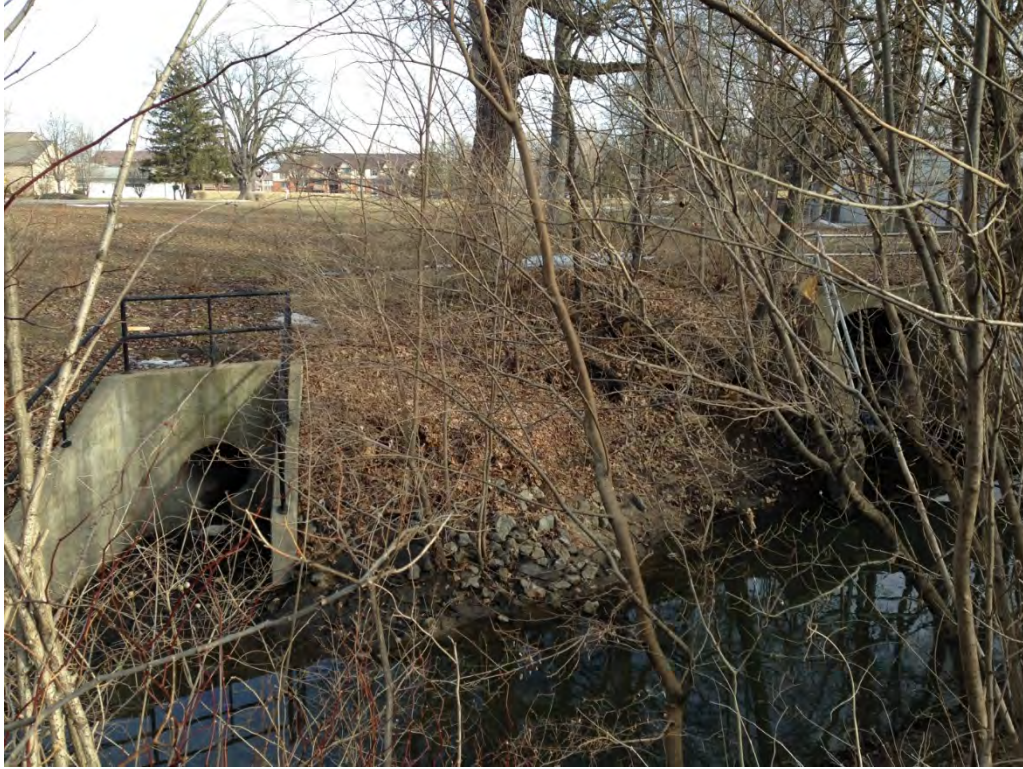
Photo 1: Two outfall culverts on RDB. These outfalls are located on transect 1 at Outfall 001.

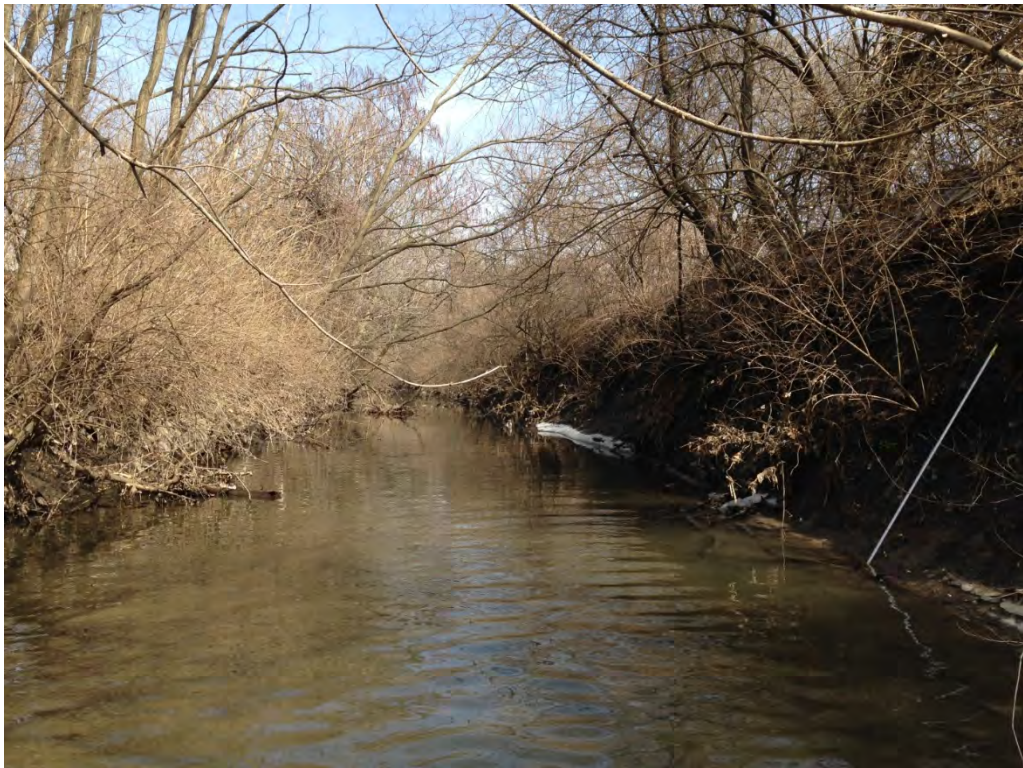
Photo 2: Looking upstream from transect 12. Bank height on LDB (right side of photo) is ~ 10 feet. Top of the bank on LDB is the upland.

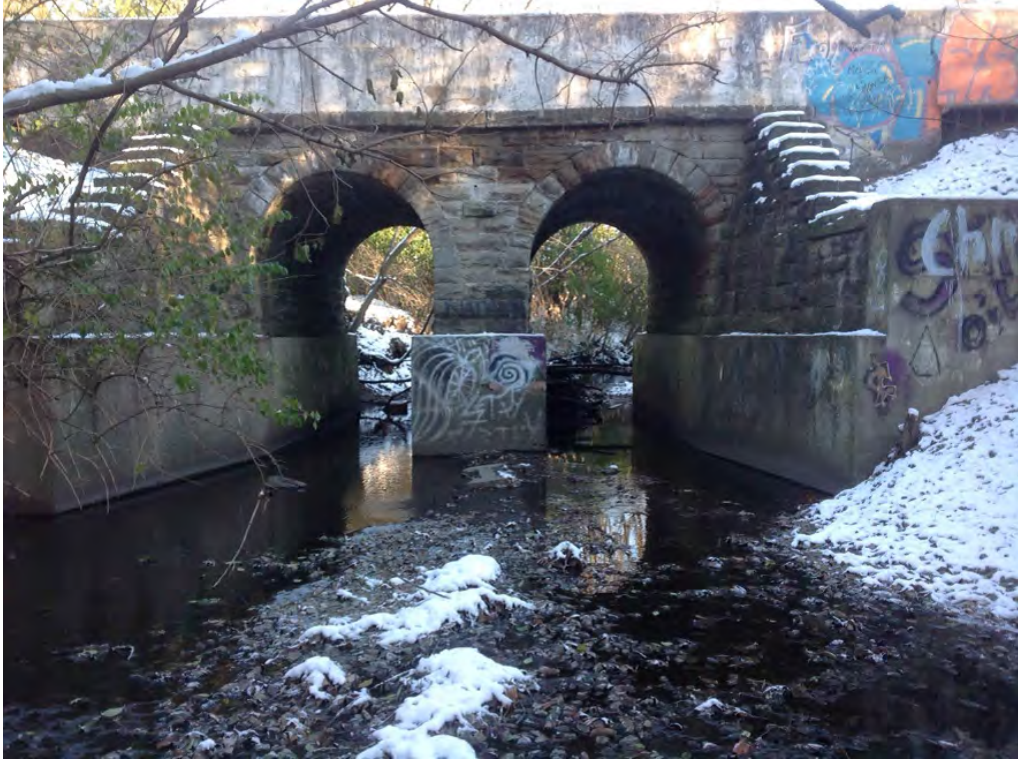
Photo 3: Looking upstream at active railroad bridge between transects 12 and 13. Stream bed consists of sand, gravel and cobbles. Poured concrete floor under bridge arches is completely exposed on RDB side bridge arch.

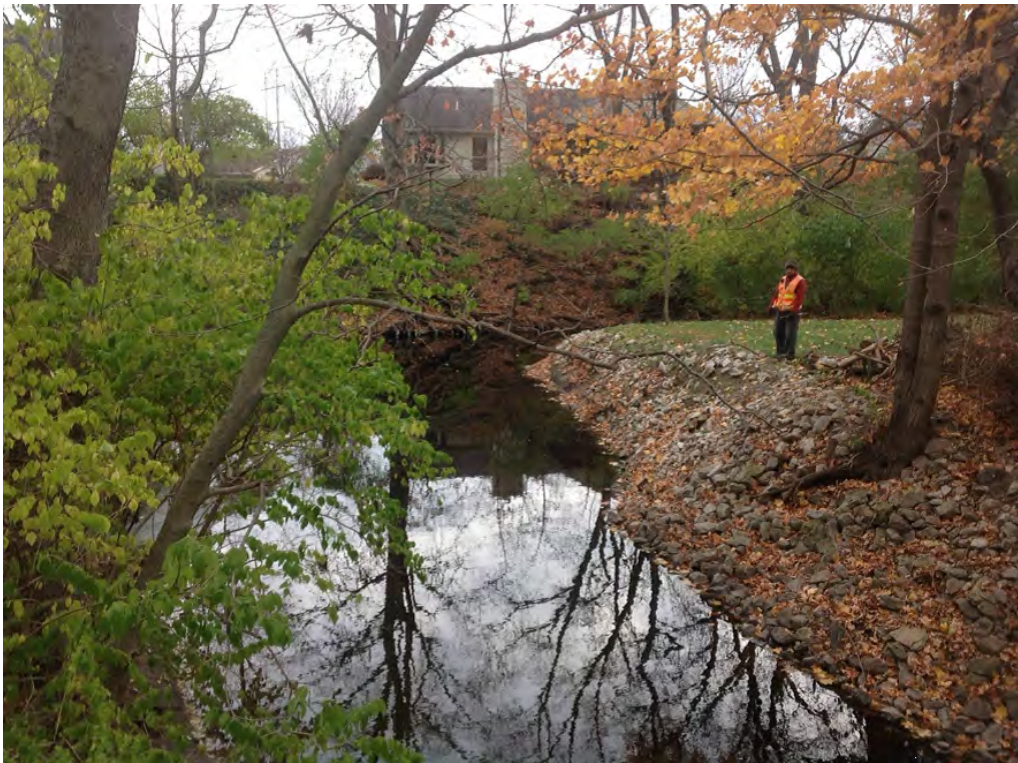
Photo 4: Looking downstream at transect 35. Person is standing on T-6. House in background is sitting on the upland.

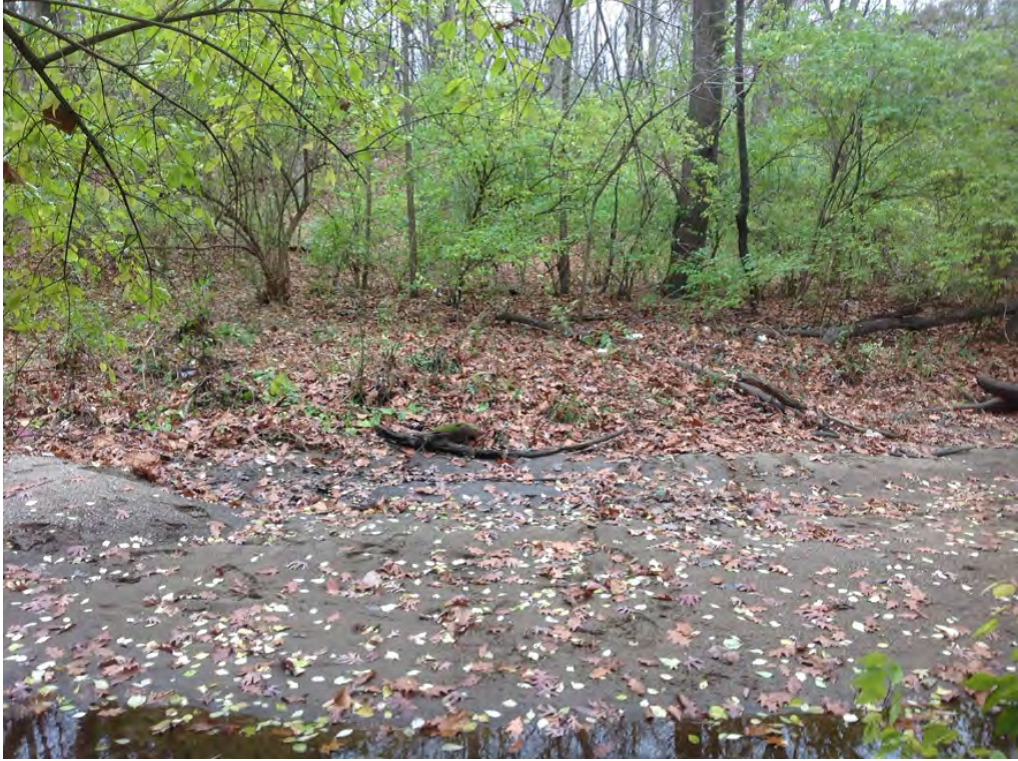
Photo 5: Looking at LDB on transect 48. The bare sand in the foreground is the floodplain surface. The T-1 surface is covered with forbs and has flood debris (garbage) and leaf litter. The T-2 surface is in background and is covered by trees and shrubs.

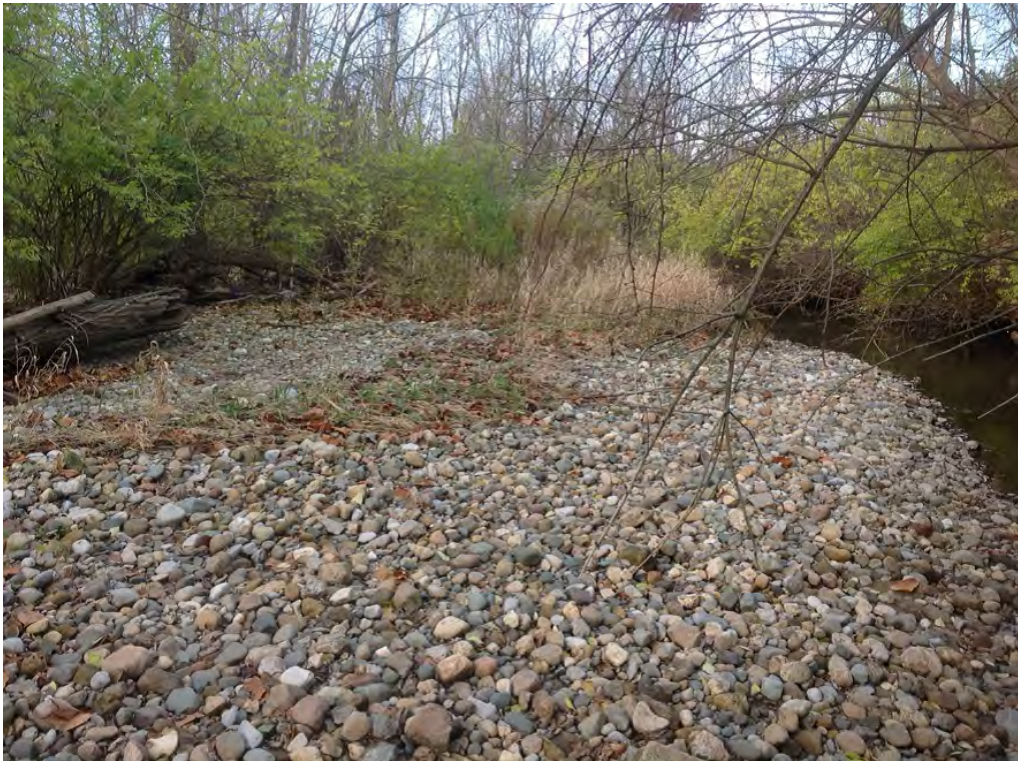
Photo 6: Looking at upstream side of meander bend near transect 60. The cobble surface is the floodplain. A small T-1 is visible where the clump of brown vegetation is located. The T-2 surface is marked by the trees and shrubs on the left of the photo.

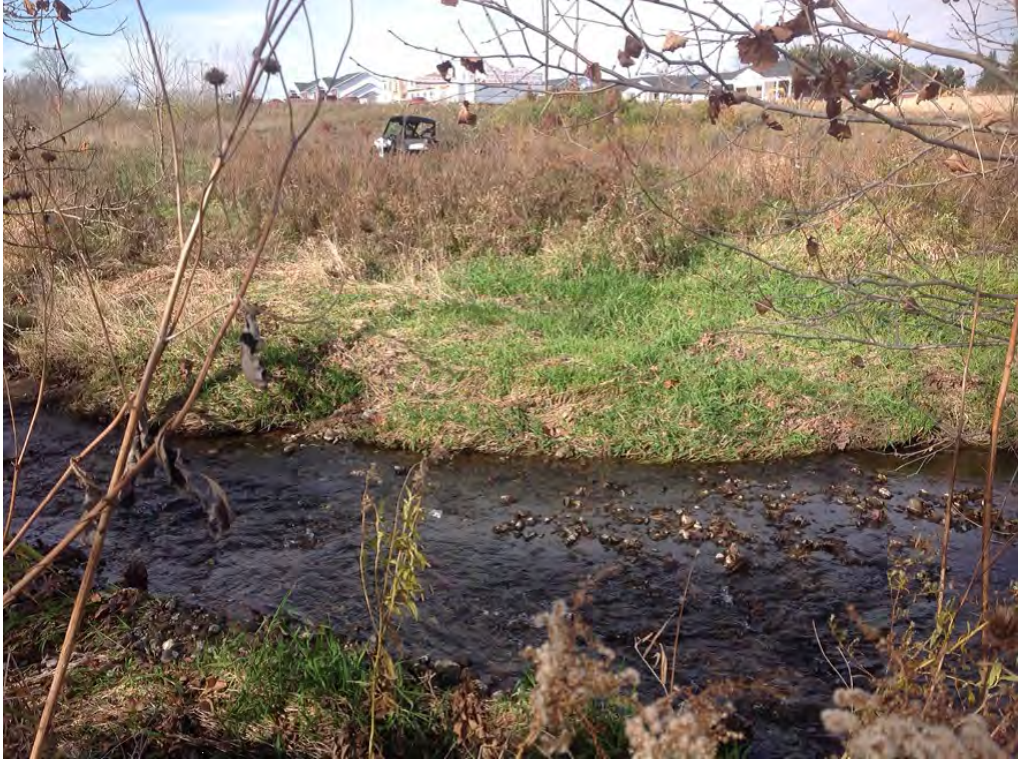
Photo 7: Looking at RDB near transect 62. ATV is parked on T-3 surface. The brown vegetation marks the T-2 surface and the T-1 surface is marked by the green vegetation by the edge of the channel.

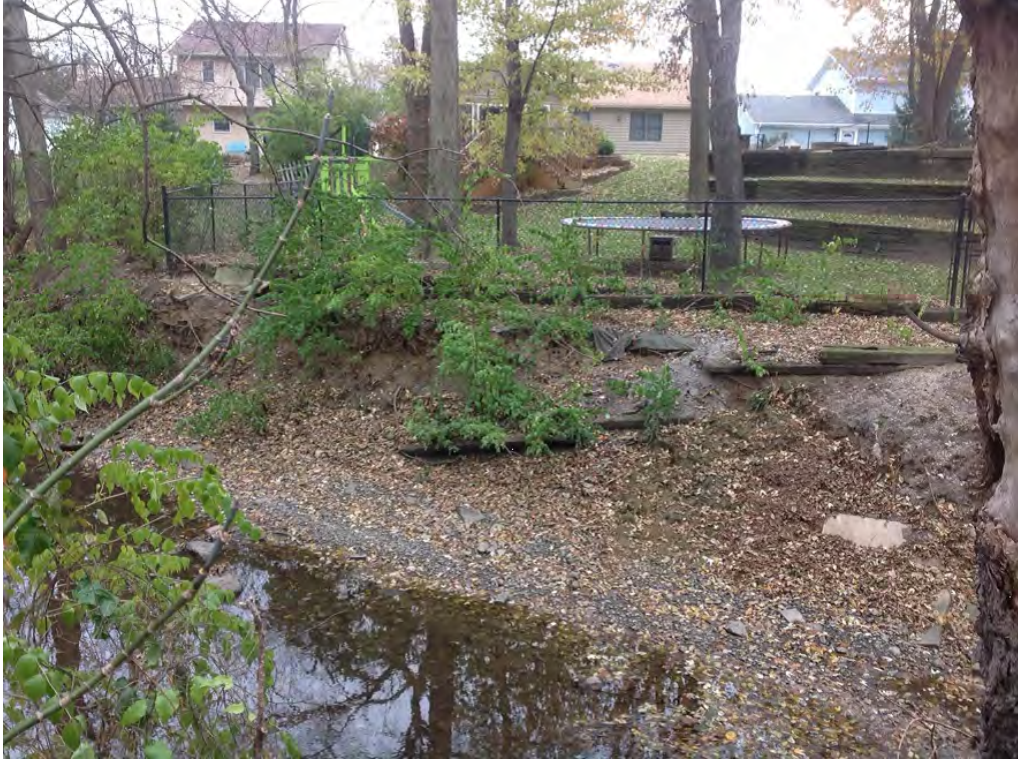
Photo 9: Looking at LDB near transect 25. Gravel surface in foreground is the floodplain. The trampoline is on the T-6 and the houses are located on the upland surface.

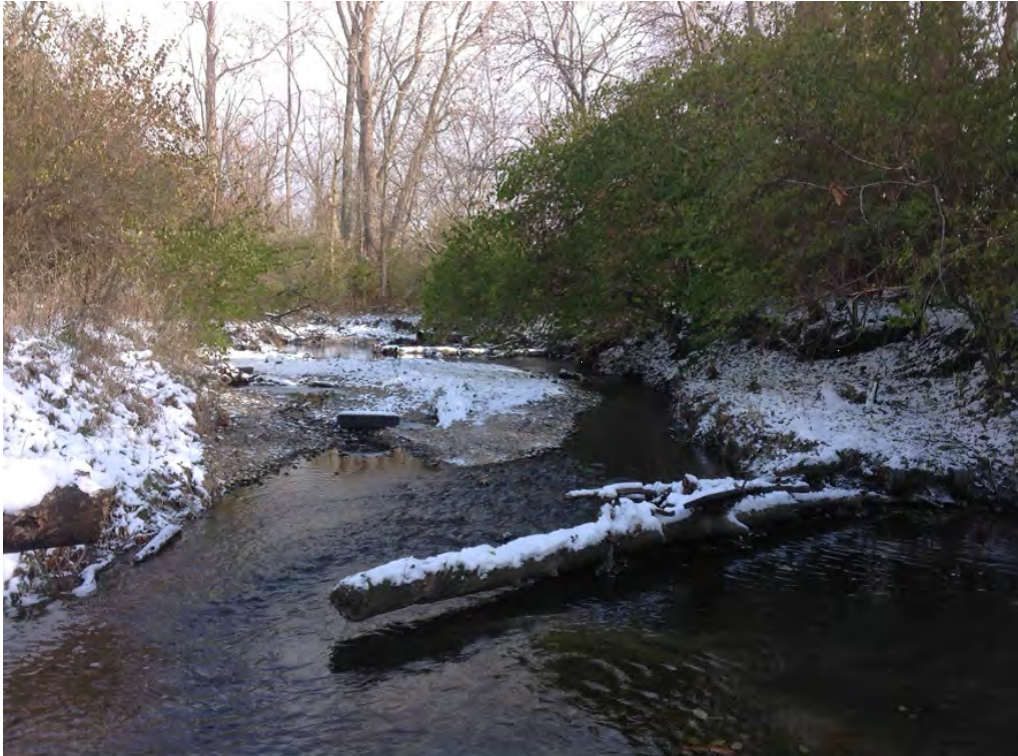
Photo 10: Looking upstream near transect 65. The sand and gravel surface in the middle of the photo is the floodplain. The T-1 is located on the right of the photo at one end of the protruding log. The T-2 is covered by trees and shrubs on both sides of the channel.

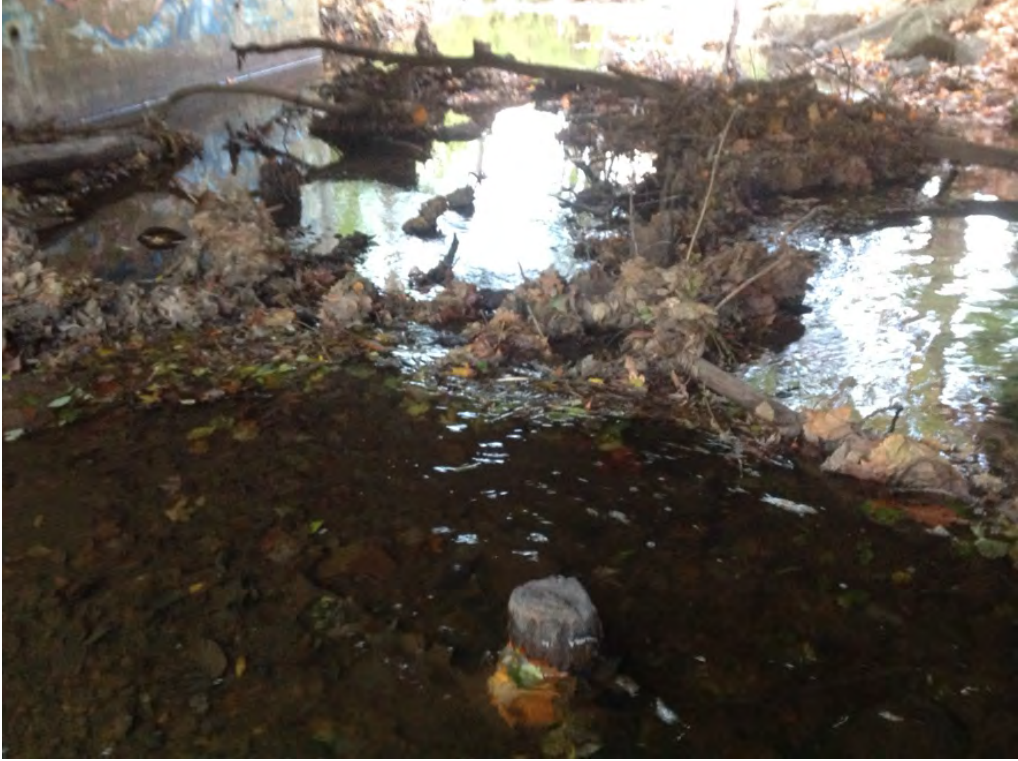
Photo 11: Old wooden bridge pylons and debris under the 9<sup>th</sup> Street Bridge.
