**RCRA CORRECTIVE ACTION  
INTERIM MEASURES WORK PLAN  
ELLIOTT DITCH – REACHES 1-3 SEDIMENT  
& ISOLATED SOIL REMEDIATION**

**ARCONIC LAFAYETTE OPERATIONS  
3131 EAST MAIN STREET  
LAFAYETTE, INDIANA 47905**

**CEC PROJECT: 172-367.0014**

**JUNE 2020**

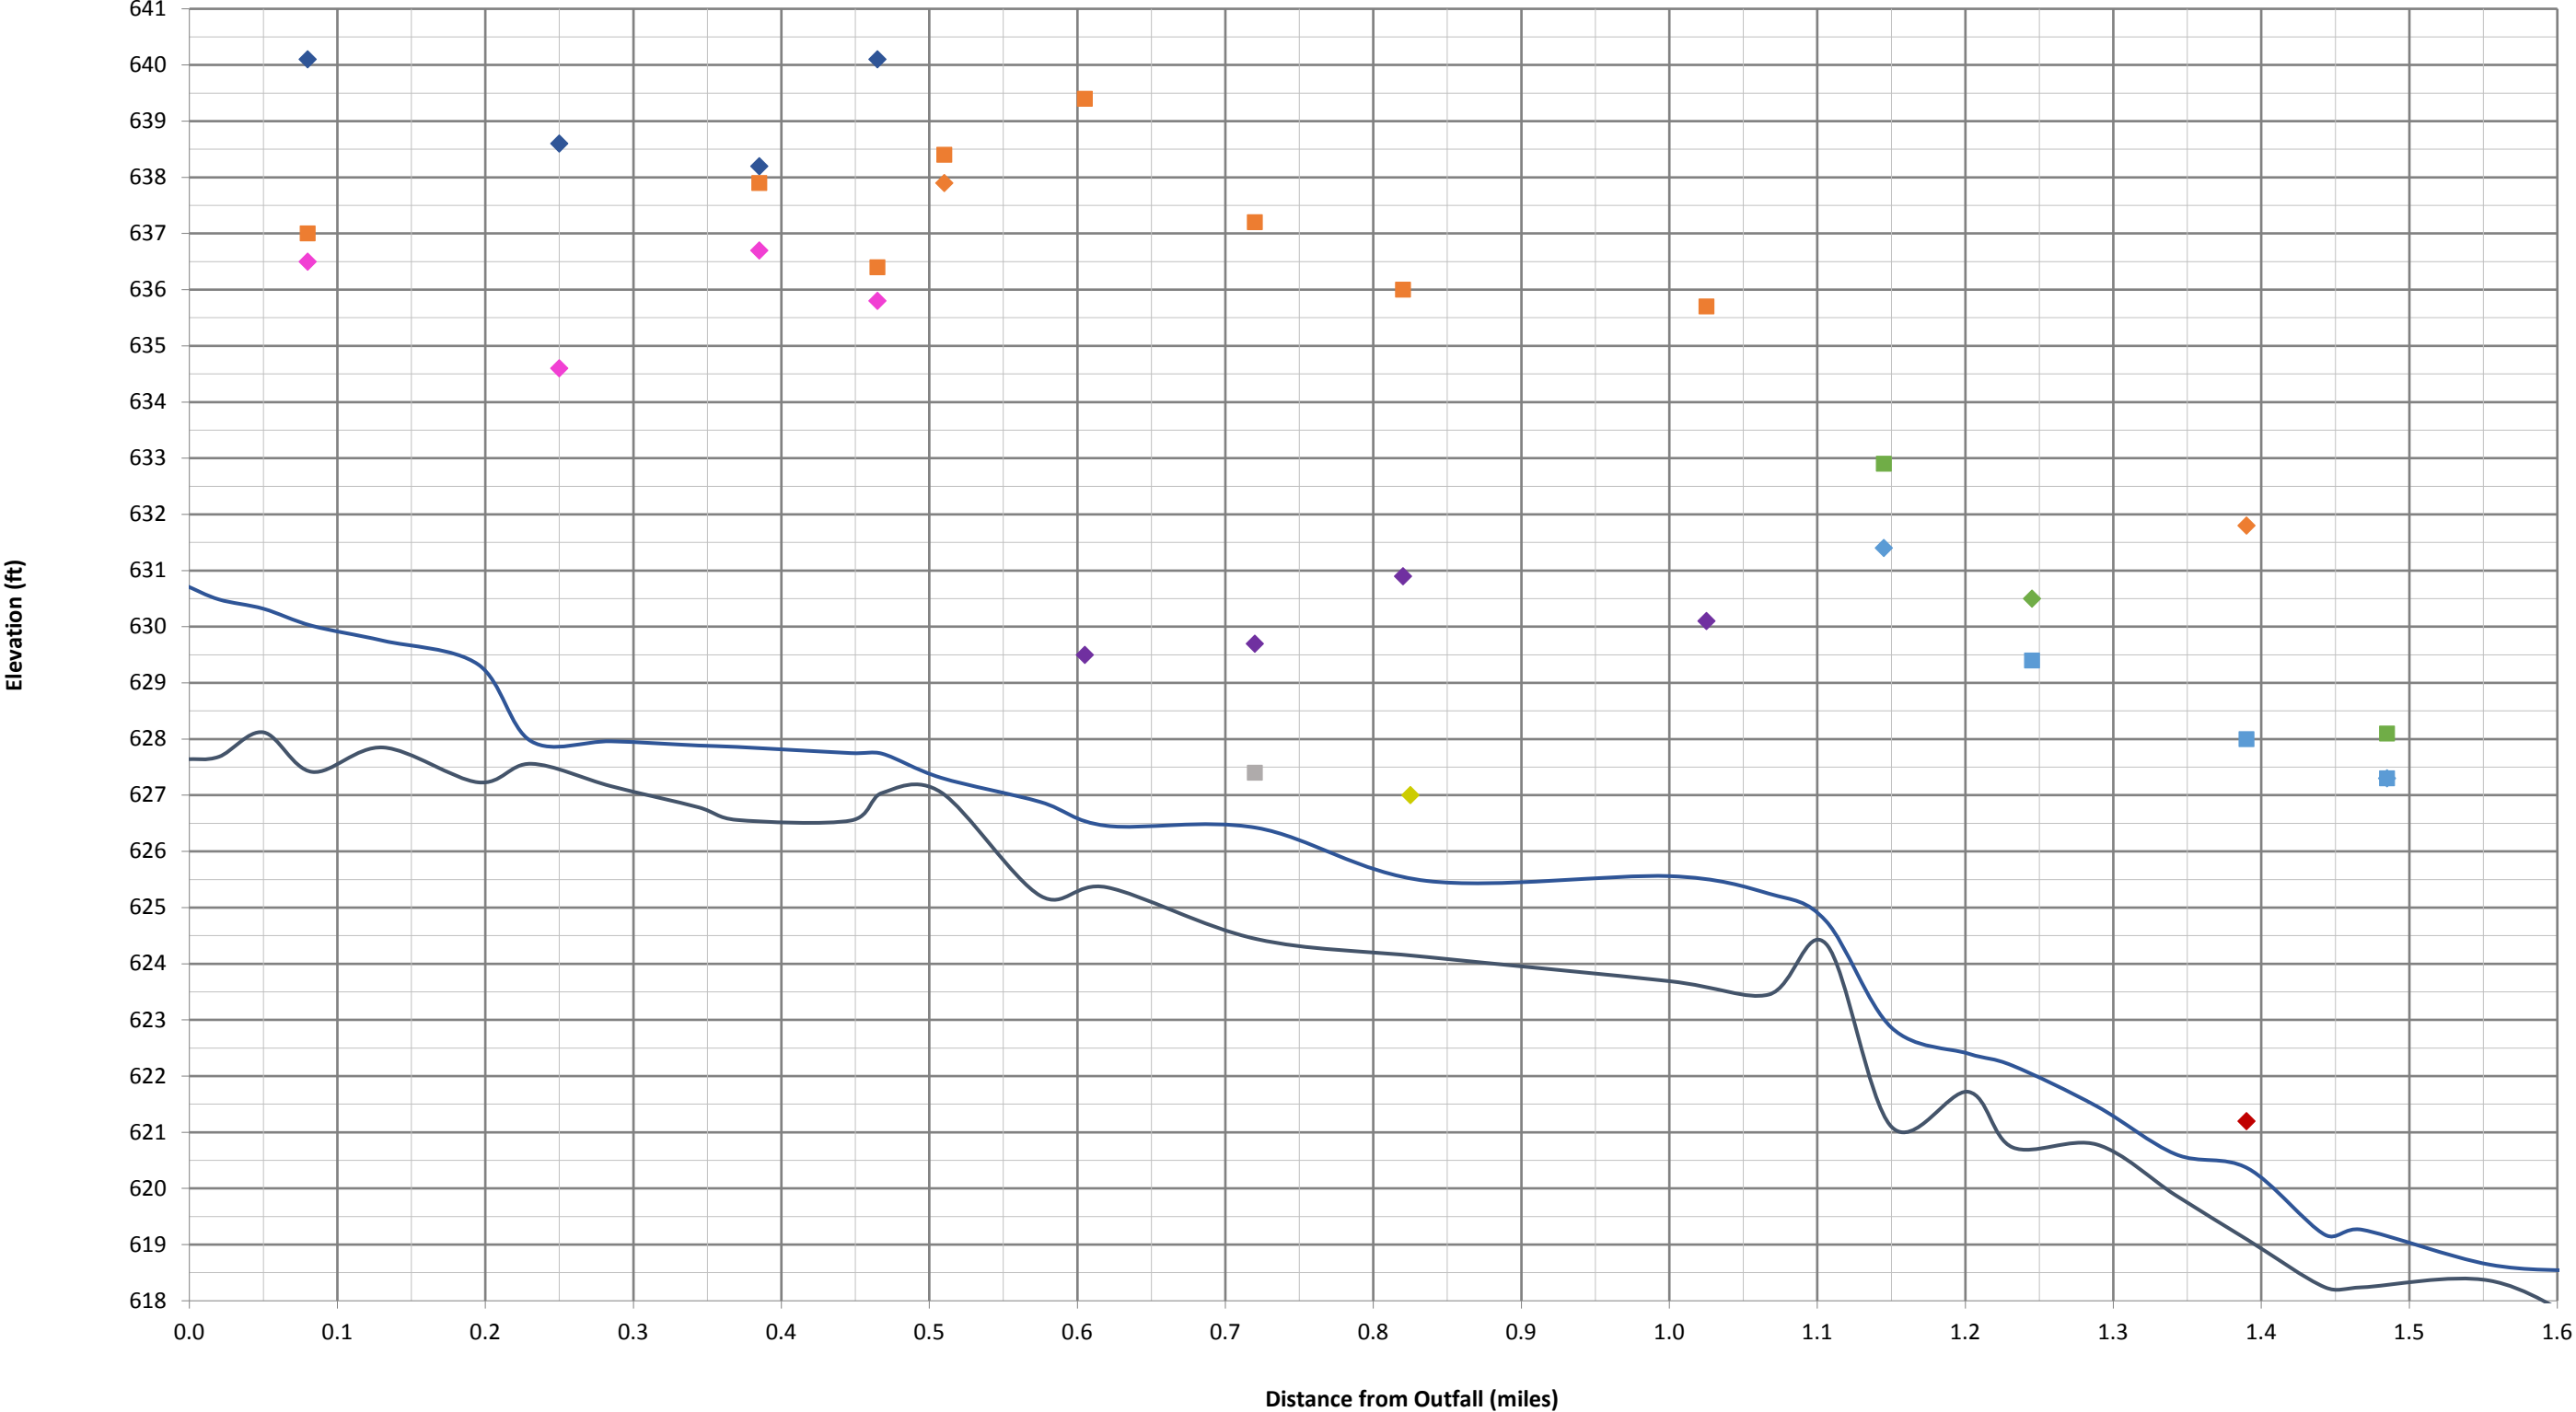
Elliott Ditch Longitudinal Profile - Outfall 001 to MP 1.6, with overbank sample locations

— Water Surface Elevation — Thalweg Bed Elevation ◆ LDB Levee ◆ LDB Upland □ RDB Upland ◆ LDB Upland Swale ◆ LDB T-7 □ RDB T-7 ◆ LDB T-6 □ RDB T-6 ◆ LDB T-4 ◆ LDB T-1 □ RDB F ◆ LDB Depression

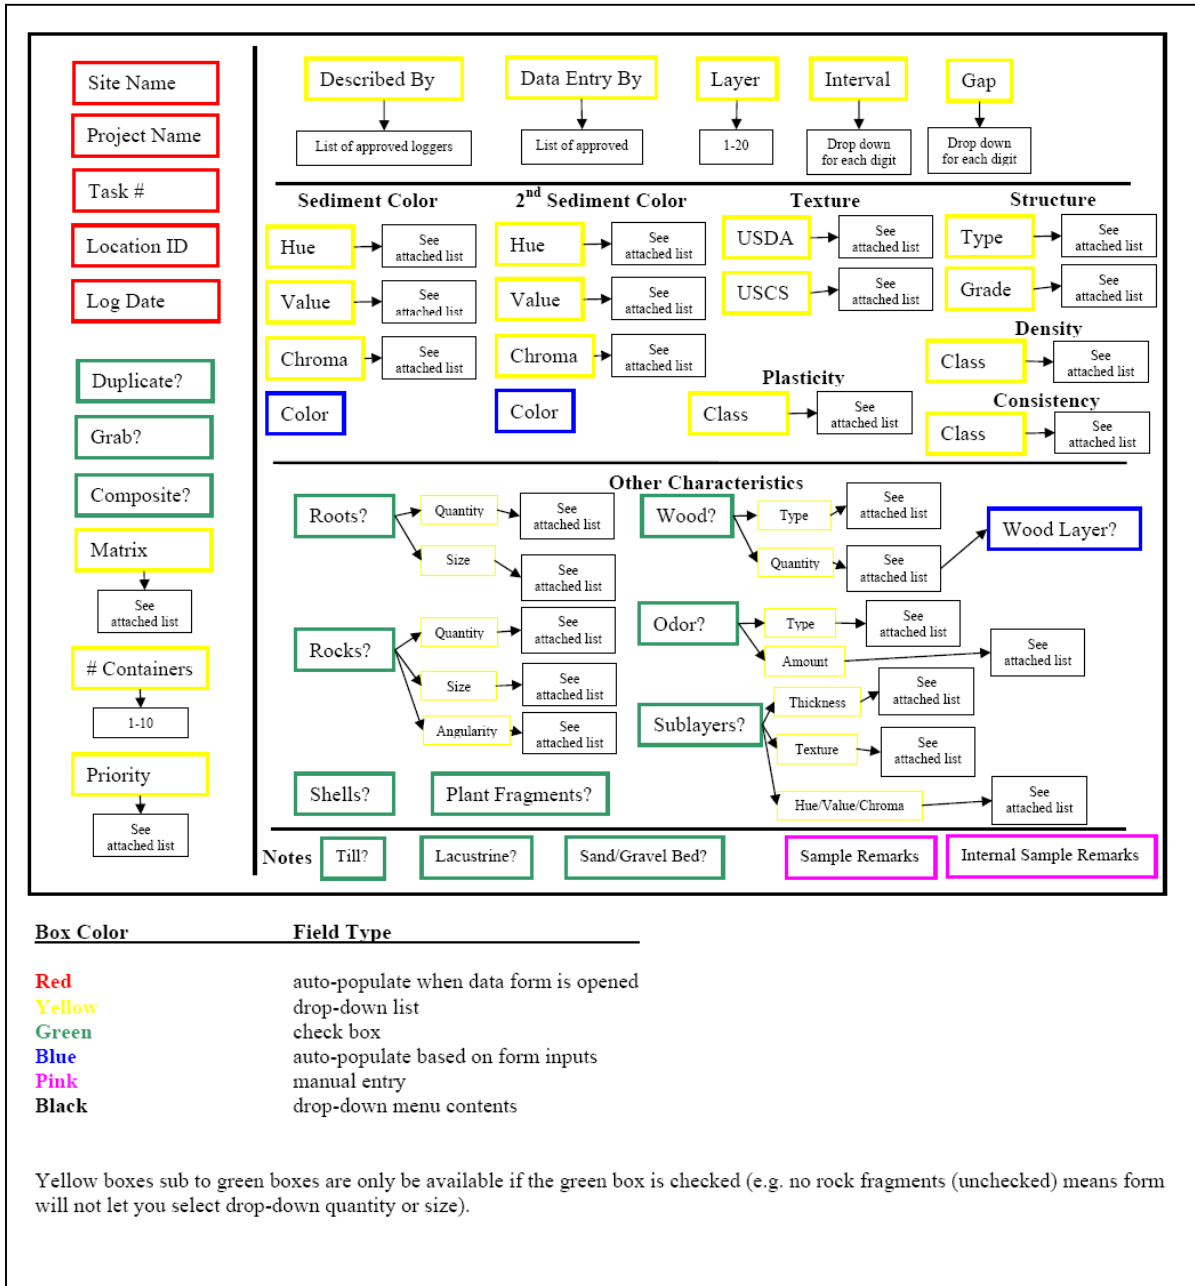
**Figure 1.** Diagram of typical electronic data collection form. “Attached list” refers to values described in this SOP.

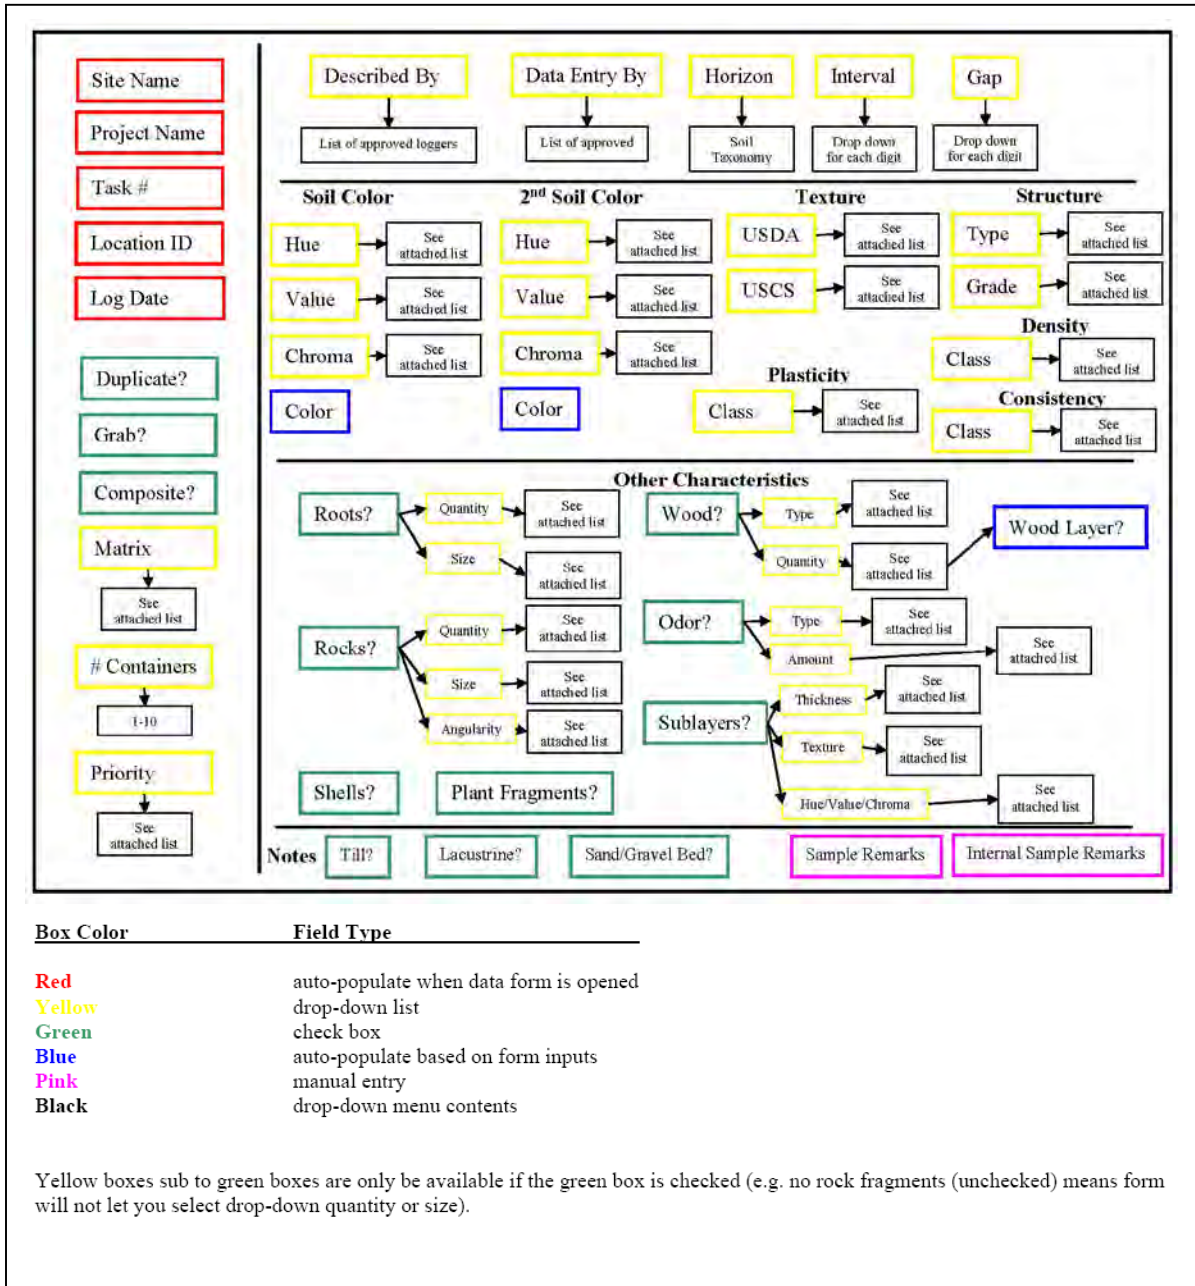
**Figure 1.** Diagram of typical electronic data collection form. “Attached list” refers to values described in this SOP.
